Appendix A1 Non-designated Heritage Asset Review Local Heritage List

Crawley Borough Council

December 2020

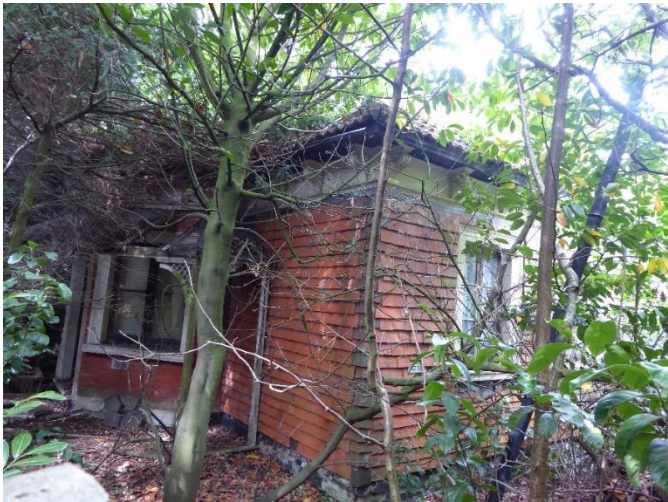
1. Name	Hamon Lodge			
2. UID	FW 02			
3. Address	Burstow Hall, Antlands Lane, Horley			
4. Postcode	RH6 9SR			
5. Grid Ref	E: 530000 N: 140606			
6a. Conservation Area	Yes	<input type="checkbox"/>	No	<input checked="" type="checkbox"/>
6b. If yes, which CA

<p>The lodge house to Burstow Hall (also locally listed; mid-nineteenth century country house) dating from the mid-nineteenth century. The structure is a typical nineteenth century gate lodge, with hung tiles to all elevations. The overhung eaves are supported by decoratively carved brackets.</p>

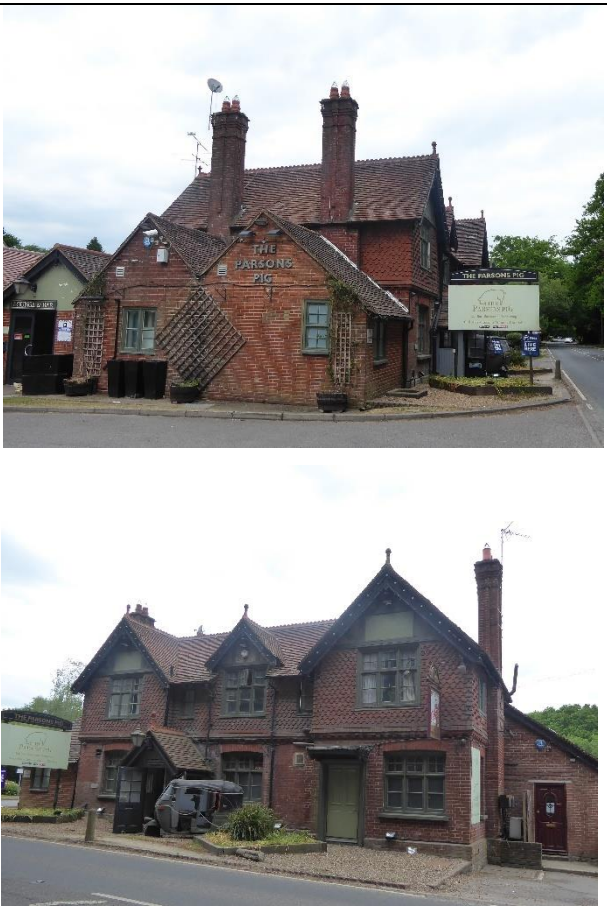
7. Description				
A large late Victorian red brick public house in the Arts and Crafts style. With timber-framed gables, a tile hung first floor and a string of dentillated brickwork directly beneath, and prominent chimneys. It has an open porch at ground floor level. The roof line has decorative clay ridge tiles.

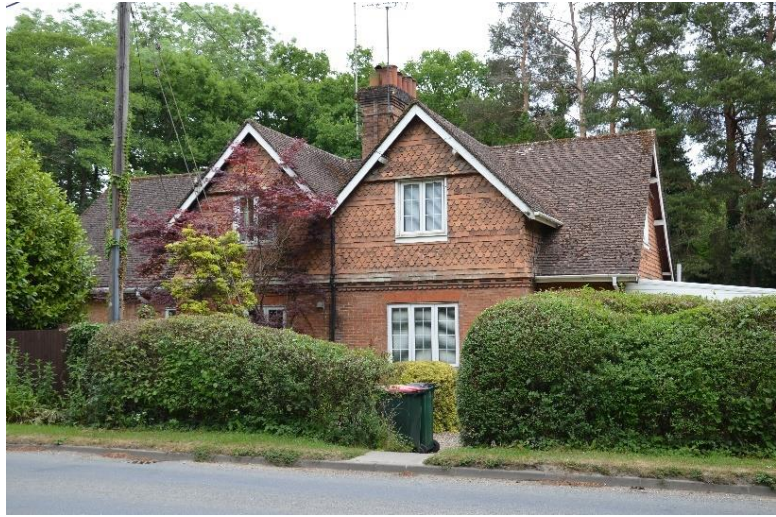
7. Description				
<p>A good example of a late Victorian cottage decorated with fish scale tile hanging at first floor level on the end gables. The unusual 'valley chimney' detail between both end gables adds character to the dwelling. A decorative brick dentil course is also an interesting part of the design. The majority of the windows have been replaced with uPVC. This property has been subdivided into two dwellings. No. 1 has a modern flat roof rear extension. No. 2 has a white uPVC conservatory side extension</p>

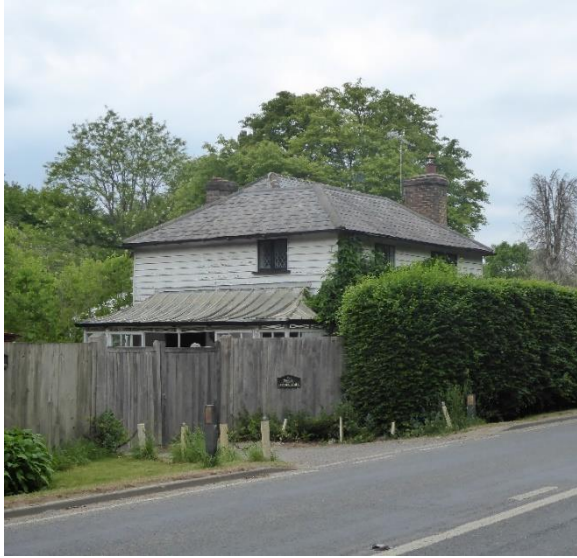
1. Name	Ten Sixty-Six			
2. UID	FW 05			
3. Address	Balcombe Road, Crawley			
4. Postcode	RH10 3NL			
5. Grid Ref	E: 529700 N: 139744			
6a. Conservation Area	Yes		No	X
6b. If yes, which CA

7. Description				
<p>Ten sixty-six has red stock brick at ground floor with white timber weatherboarding at first floor. The roof is of slate. The leaded windows at ground floor level appear to be original. To the south elevation is a veranda with a swept rolled lead roof, enclosed partly with glazing.</p>

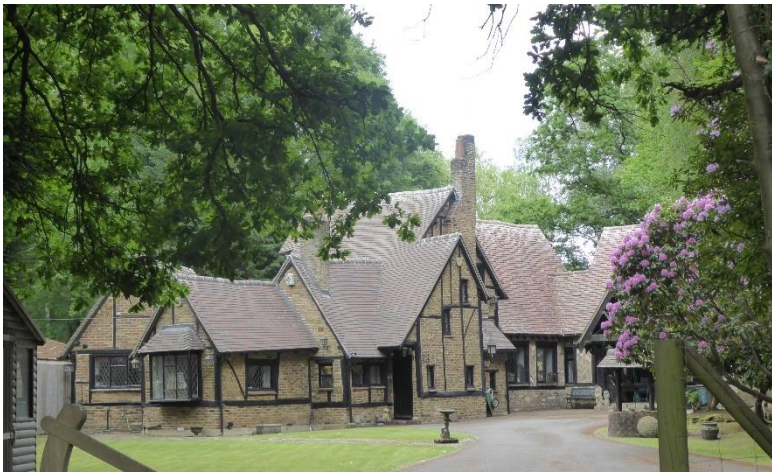
7. Description				
<p>The Cottage in the Wood was originally called 'Little Timbers' and was designed by Blunden Shadbolt, an architect known for picturesque timber-framed buildings designed to look ancient. It was constructed between 1931 and 1933 on the plot of a dilapidated gamekeeper's cottage.</p> <p>A timber framed house with brick infills, prominent chimney stacks, single glazed leaded lights within a woodland setting. Post war single storey extension on the side of the property.</p>

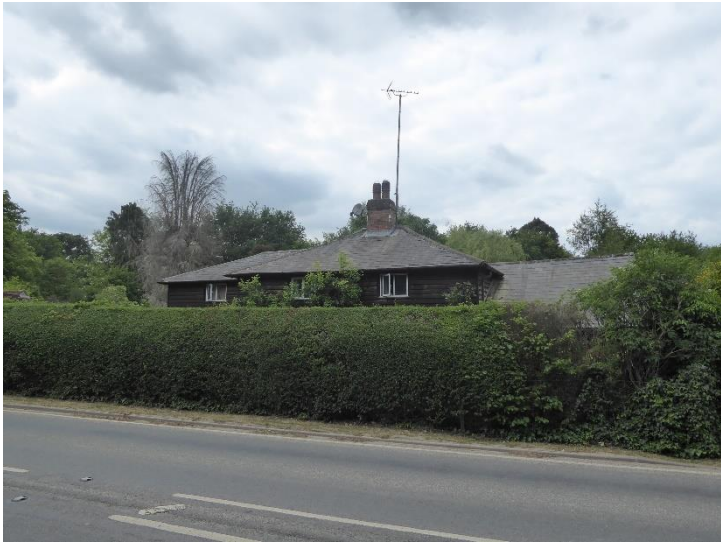
1. Name	The Open Door

2. UID	FW 07			
3. Address	The Open Door, Balcombe Road			
4. Postcode	RH10 3NL			
5. Grid Ref	E: 529699 N: 139747			
6a. Conservation Area	Yes	<input type="checkbox"/>	No	
6b. If yes, which CA				
7. Description				
A late century cottage. It has a dark red stock brick at ground floor with black timber weatherboarding at first floor. The roof is of slate. The leaded windows at ground floor level appear to be original.

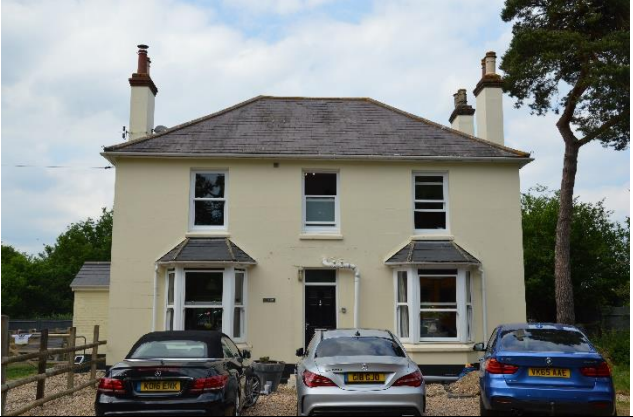
7. Description				
<p>A detached three bay mid-nineteenth century house. The ground floor bay windows may be later additions. Retains original slate roof, however windows have been replaced with UPVC and the front door is not original. A previous porch has been removed however the scar left is visible in the render. In the location of the removed porch, a poorly sited and detailed white UPVC soil pipe has been installed though this may have been present prior to the porch's removal. The render shows evidence in places of being scored in courses to appear as ashlar, this may be a historic original feature that has been successively over-rendered and overpainted.</p>

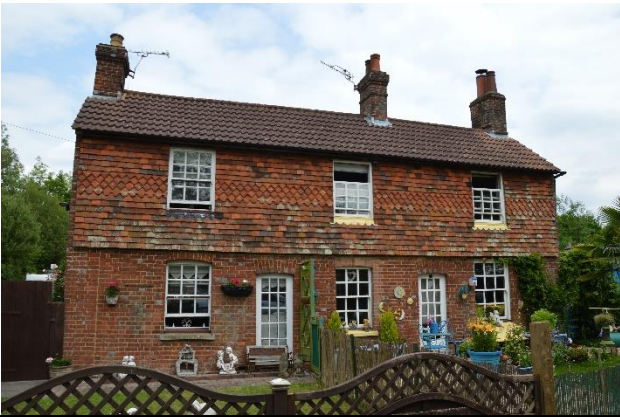
7. Description				
<p>Mid-nineteenth century three-bay detached house, with variegated brickwork, which is mostly red brick but with some purple glazed headers. The first floor is hung with clay tiles and includes a decorative band of diamond and fish scale tiles. Retains its original six pane sash windows, although external doors have been replaced with French windows and the original roofing replaced with concrete tiles.</p> <p>This property has since been divided into two separate dwellings. The building has historically undergone alterations and remodelling, the evidence of which is visible in the alterations and extension lines in the brickwork, differing window openings, and the placement of the chimney stacks. The rear has a lean-to extension with a catslide roof which appears to be a later addition, potentially dating from the late twentieth century.</p>

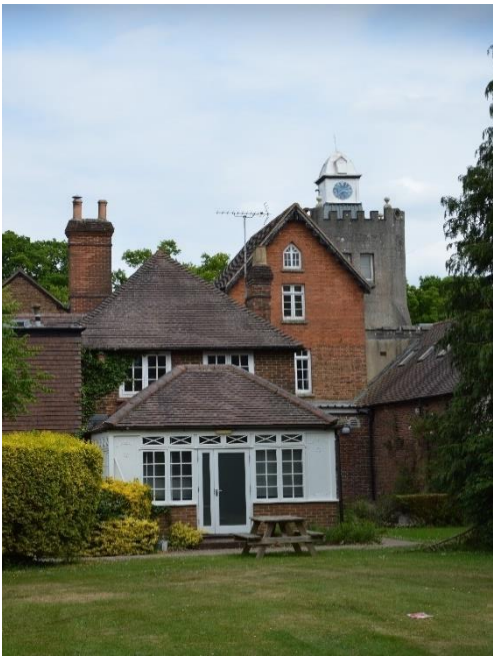
7. Description				
<p>A multiphase complex of buildings now used as offices but originally a Victorian country house formerly known as 'The Gables'. The most prominent building is a Neo-Gothic range of 1876 which is eleven bays, rendered in concrete, with quoins, dressed lintels, rustic partial side reveals and a central castellated tower which features a clock tower to its roof. There is an earlier Victorian red brick range to the north of this neo-gothic range, as well as some twentieth century Neo-Georgian buildings.</p>

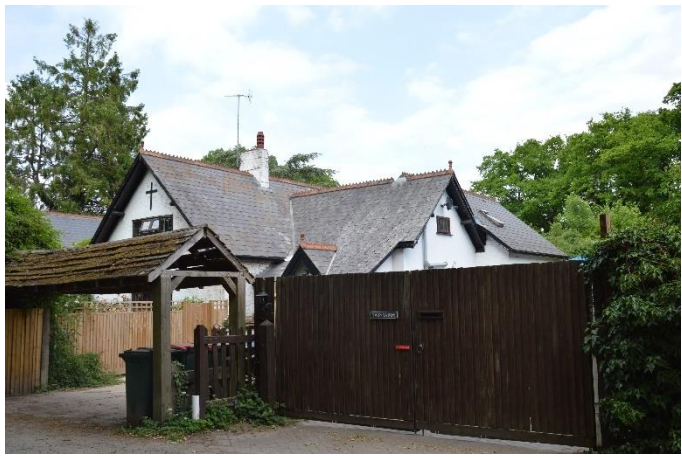
7. Description			
<p>This is brick chapel dating from 1885 has been converted into a house. A black crucifix and the date 1885 is marked on the street facing gable beneath the eaves. The original slate roof and decorative ridge tiles are original. There is a later extension to the rear, and the windows have been replaced throughout. The street facing gable features brick supporting kneelers.</p>

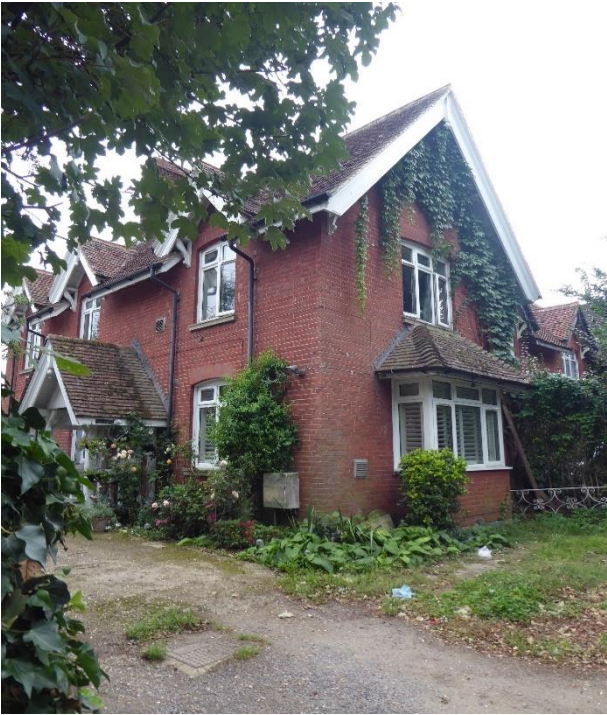
7. Description			
<p>The property is a former nineteenth century farmhouse, formerly one property now divided into two dwellings. It is constructed in red brick laid Flemish bond. The property has a prominent gable front with overhung soffits with exposed rafters supported by timber brackets to the front elevation. There is a decorative pendant finial to the gable pitch.</p>

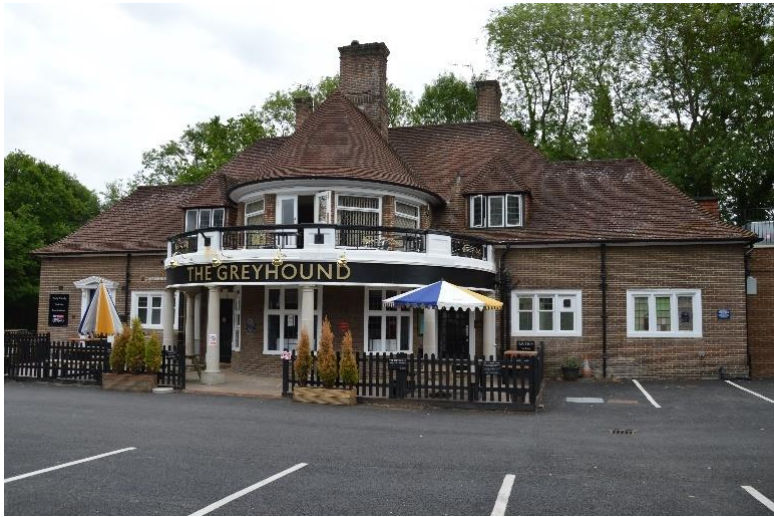
7. Description			
<p>A 1930s public house of eclectic design; it is symmetrical with both neo-classical and Arts & Crafts detailing. Constructed from dark red brick. There is a central curved projecting bay which has a conical roof, topped by a tall central chimney with two flanking chimneys to the southeast and south west, all of which feature decorative brickwork and moulded stone coping and a stringcourse. A semi-circular colonnade forms the entrance with pairs of Doric columns supporting a semi-circular balcony with wrought iron balustrade including greyhound motifs. One of the Doric columns has been replaced. Windows are largely timber casements with diamond or square patterned leading to them and fixed within deep moulded stone surrounds, painted white. The interior includes a copper capped hardwood rail, leaded windows and neoclassical plastered door.</p>

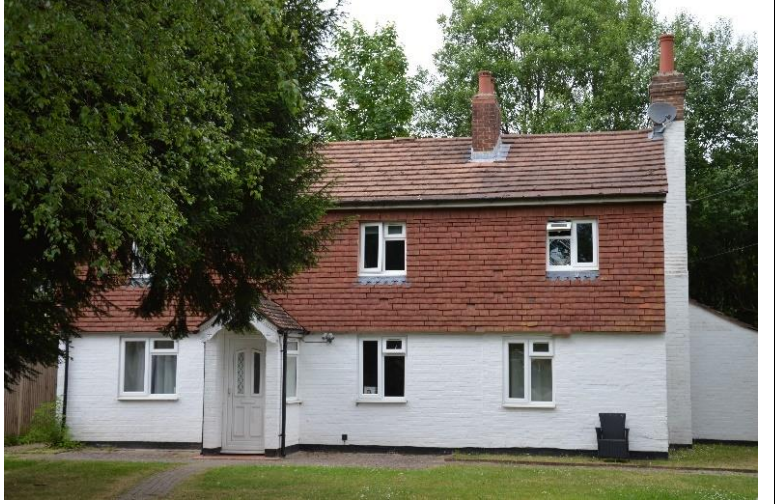
7. Description			
<p>The original local list description states that this cottage was built c.1780s but the condition of the brickwork and roof might suggest a later date, a rebuilding or refacing of the building, perhaps in the early nineteenth century. The building has a range extending northwards from the centre of the western three bays to the cottage. The windows have all been replaced with uPVC. There is painted stock brick at ground floor level and simple clay hung tiles at first floor and on the roof. The building has a later porch extension with a decorative barge board. The easternmost bay is potentially an extension to the original three bay cottage to the west. This potentially evidenced by three vertical joining lines are visible in the brickwork indicating that the building may have had a secondary entranceway here or a large opening, the additionally gable chimney on the east gable is also a further potential indication of this.</p>

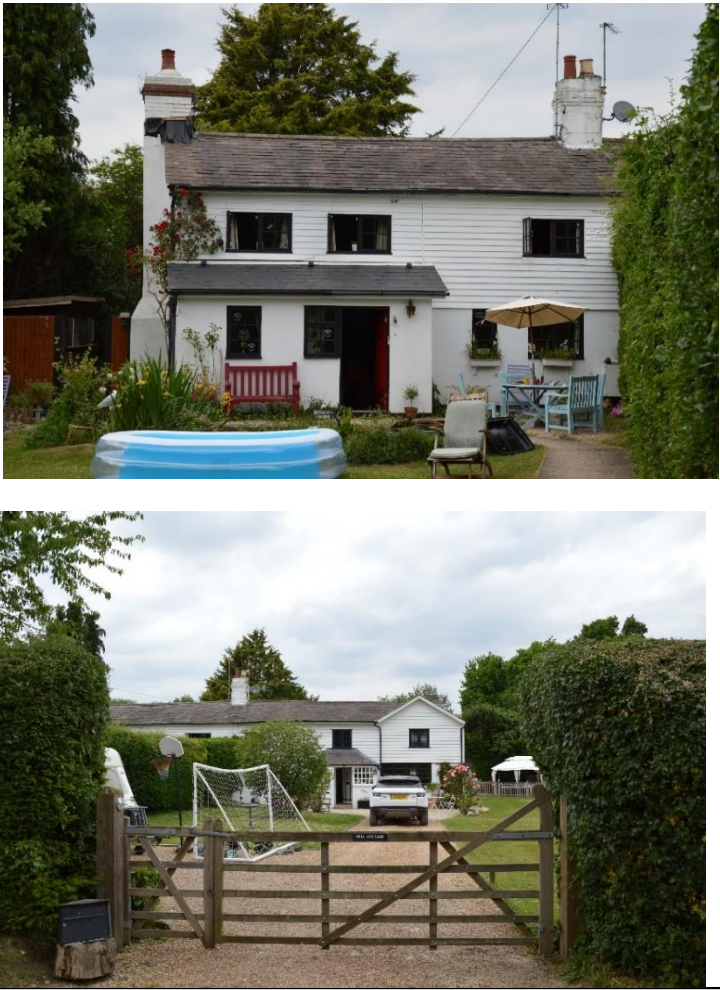
7. Description				
<p>An example of two worker's cottages from the late eighteenth century. The two-storey end gable extension to the east of Zell Cottage and the entrance porches to both cottages are later additions. The first-floor front elevations are faced in traditional painted weather boarding. The roof is of slate with a traditional shallow pitch. Newbridge Cottage features a gable chimney to its west gable which may be a twentieth century addition.</p>

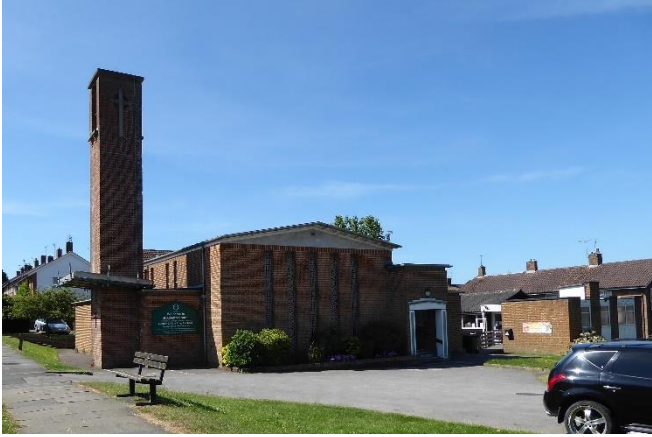
7. Description			
<p>St Albans Church was Consecrated in 1962 and is unusually set on a south-north axis, parallel to the road and Gossops Green parade and adjacent to a green. It is a Composite structure of red brick, concrete and steel; the main roof has shallow pitch with aluminium sheeting and the low roofs are covered with bituminous felt. There is a bell tower and five stained glass windows in the north elevation. This church is an important component of Gossops Green neighbourhood centre and is a landmark of local architectural and historic interest.</p>

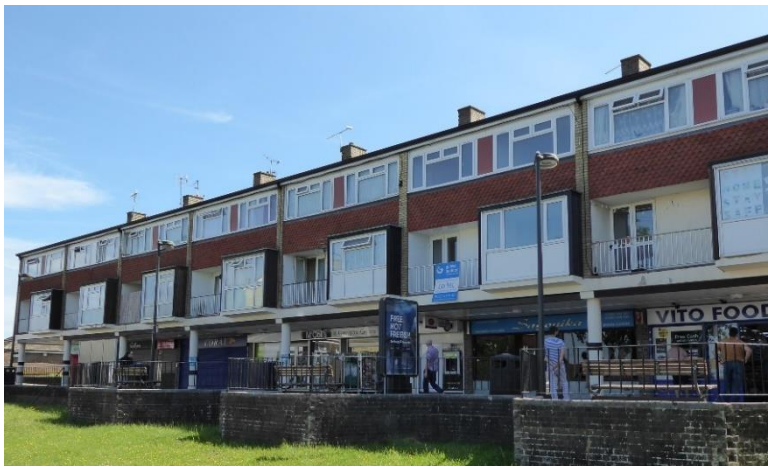
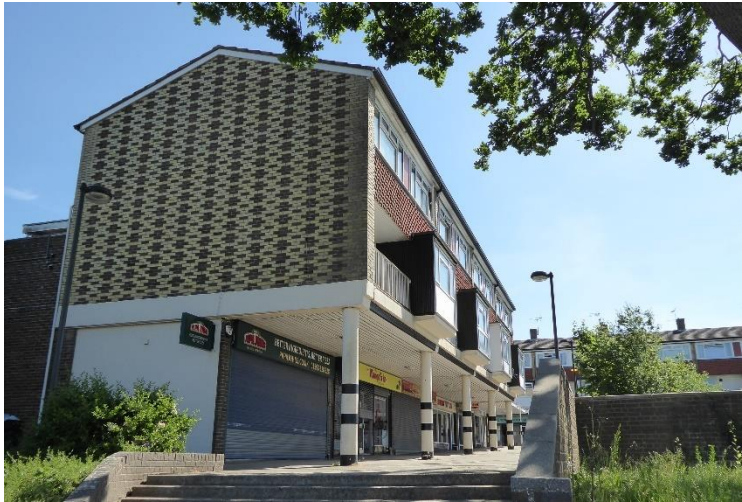
7. Description			
<p>The two rows are three storeys with shops at ground floor and residential units on the upper two storeys. The parade is set in an L-shape form with The Windmill Public House at the centre of the courtyard. The shops at ground floor level are recessed under a colonnade. The columns are simple concrete. The parade consists of cantilevered lintels and protruding decorative boxed bay windows at the ground floor level. Rusticated architectural detail in the second-floor level includes traditional clay fishscale tiles. The side elevation facing Gossops Drive has diapering brick detailing.</p>

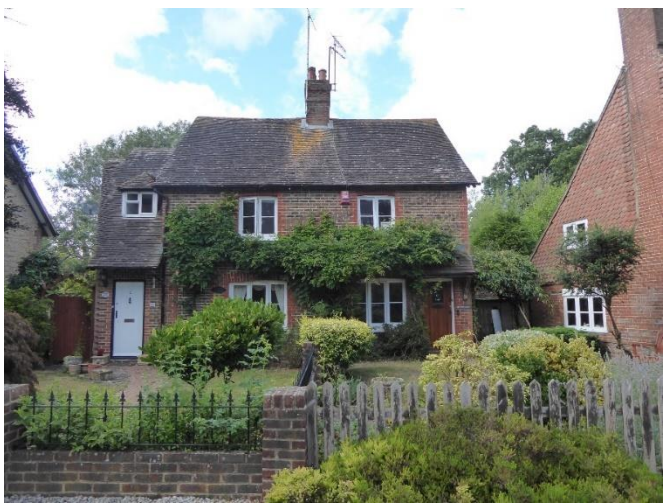
1. Name	1-2 Church Cottages		
2. UID	I 01		
3. Address	1-2 Church Cottages, Ifield Street, Ifield, Crawley		
4. Postcode	RH11 0NN		
5. Grid Ref	E: 524764 N: 137606		
6a. Conservation Area	Yes	<input checked="" type="checkbox"/> X	No
6b. If yes, which CA	Ifield Village Conservation Area

7. Description			
<p>Semi-detached cottages dating from the late nineteenth century. Constructed in dark brick with red brick quoin detailing, under a plain tile roof with a prominent central chimney stack. Number 1 Church Cottage has a one and a half storey extension with a hipped dormer.</p> <p>These buildings form the historic core of the Ifield Village, the character of which is recognised by the Conservation Area designation.</p>

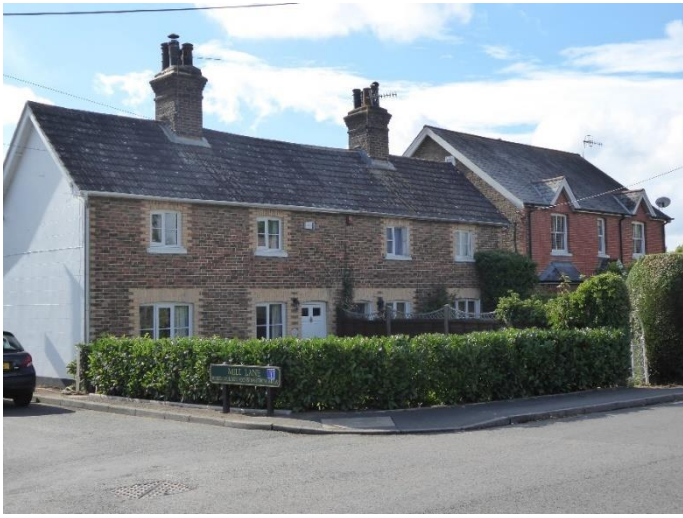
1. Name	Laburnum & Roslyn Cottages			
2. UID	I 04			
3. Address	Laburnum & Roslyn Cottages, Ifield Green			
4. Postcode	RH11 0ND			
5. Grid Ref	E: 525117 N: 137895			
6a. Conservation Area	Yes	X	No	
6b. If yes, which CA	Ifield Village Conservation Area

7. Description				
<p>Pair of semi-detached cottages with gable ends. The cottages are faced with dark brick laid in Flemish bond with light brick quoin and lintel detailing, dating from the mid nineteenth century.</p>

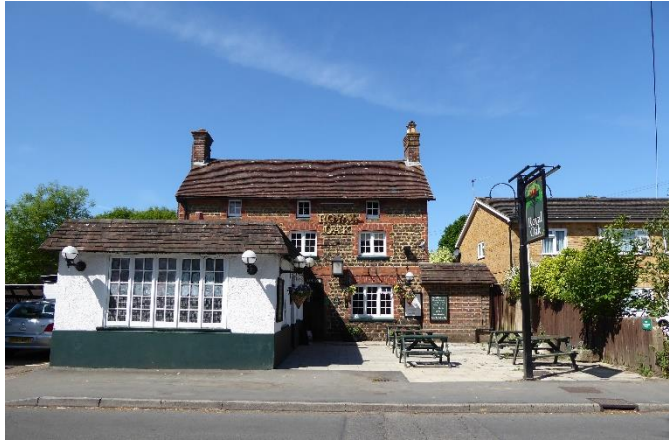
1. Name	The Royal Oak		
2. UID	I 07		
3. Address	The Royal Oak, Ifield Green,		
4. Postcode	RH11 0ND		
5. Grid Ref	E: 525104 N: 137942		
6a. Conservation Area	Yes	<input checked="" type="checkbox"/>	No
6b. If yes, which CA	Ifield Village Conservation Area

7. Description			
<p>This is a rare example of the use of ironstone in the Crawley area in an early-mid nineteenth century public house. The ironstone principal elevation is horizontally articulated with a deep red stock brick string course, and the building has brick quoins and lintels. The building is two and a half storeys, retains original features such as the chimney stacks and casement windows. The pub has a 1960s single storey mansard extension to the front.</p>

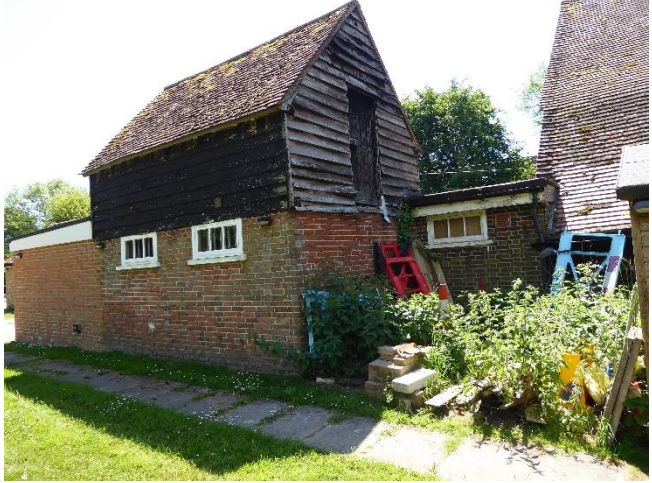
1. Name	Hayloft/Granary to the rear of the Barn Theatre		
2. UID	I 09		
3. Address	Barn Theatre, Ifield Street,		
4. Postcode	RH11 0NN		
5. Grid Ref	E: 524694 N: 137630		
6a. Conservation Area	Yes	<input checked="" type="checkbox"/>	No
6b. If yes, which CA	Ifield Conservation Area

7. Description			
The hayloft/granary located to the rear of the locally listed Barn Theatre. The Hayloft/granary is constructed in red brick to the lower floor with black weather board to the upper half.

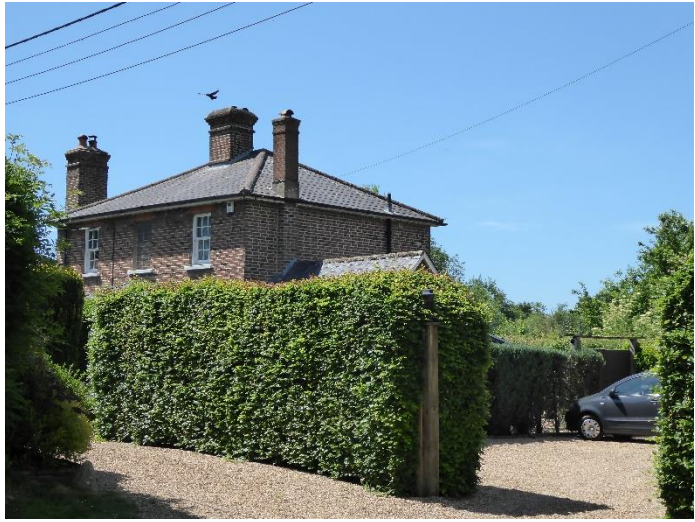
7. Description			
<p>A large two storey dark red brick hipped roof of three bays, the central first floor window is bricked up. The building has a grey slate roof with large central chimney stack. Constructed c.1860s. The open porch is typical of this period.</p> <p>There is a part front and side single storey extension with a hipped roof.</p>

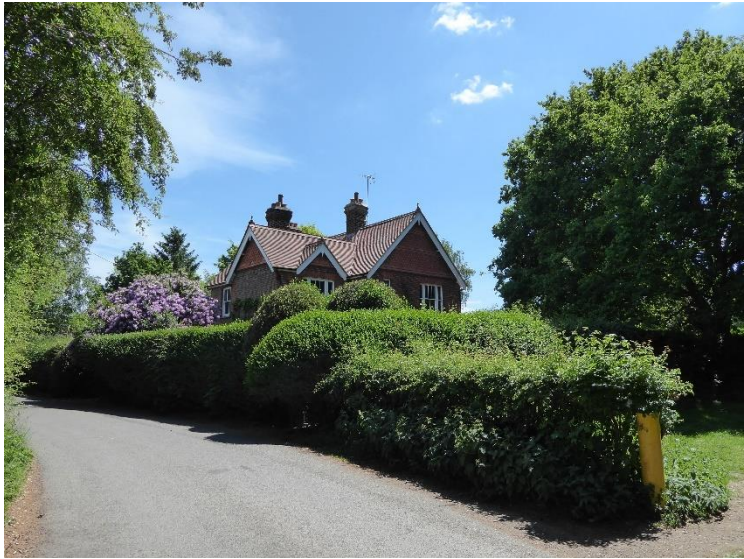
1. Name	Brooklands

2. UID	I 12			
3. Address	Brooklands, Rectory Lane,			
4. Postcode	RH11 0NQ			
5. Grid Ref	E: 525029 N: 138001			
6a. Conservation Area	Yes	<input checked="" type="checkbox"/>	No	
6b. If yes, which CA	Ifield Village Conservation Area			
7. Description				
<p>Large, detached late Victorian villa. It is a good example of the restrained use of high-quality red stock brick on the main walls and fish scale tiled end gables. The tiled end gables are dressed abutting the brickwork with original brick dentils. The building has large corbelled chimneys and original timber sash windows.</p>

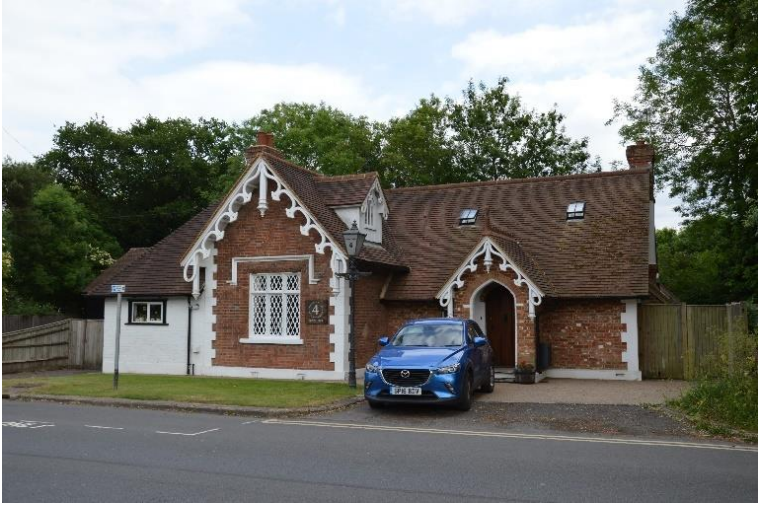
7. Description			
<p>The lodge house is the only building remaining of pre-airport Gatwick Manor, not to be confused with the neogothic Gatwick House further to the east. The original structure is of variegated brick in Flemish Bond with purple glazed headers and white painted stone quoins under a tiled roof. The building is in a picturesque with attractive carved bargeboards with pendants to the roof and front porch. Stone mullion windows with drip moulds. The large window to the street elevation features diamond pattern iron glazing.</p>

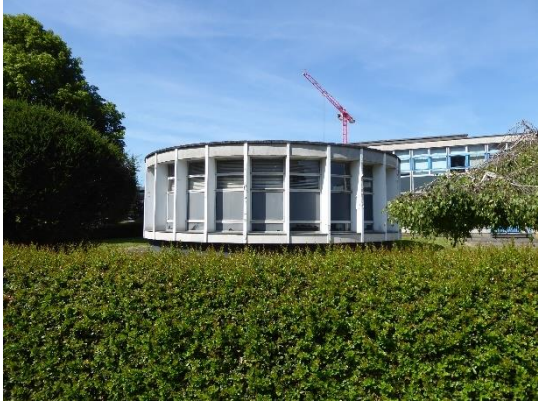
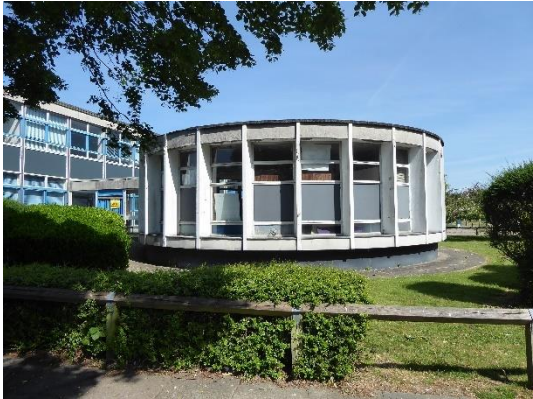
1. Name	Old Children's Library		
2. UID	NG 01		
3. Address	Old Children's Library, County Buildings, Northgate		
4. Postcode	RH10 8BF		
5. Grid Ref	E: 527349 N: 136885		
6a. Conservation Area	Yes	No	X
6b. If yes, which CA

7. Description			
A rotunda/ drum shaped structure with flat roof that bridges onto the West Sussex Fire and Rescue Service building (now disused). Set on a recessed plinth, constructed from reinforced concrete.

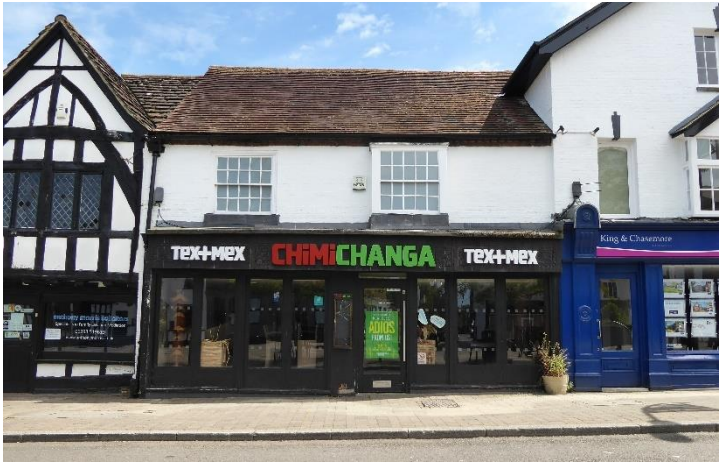
1. Name	47 High Street		
2. UID	NG 02		
3. Address	47 High Street,		
4. Postcode	RH10 1BQ		
5. Grid Ref	E: 526778 N: 136569		
6a. Conservation Area	Yes	<input checked="" type="checkbox"/>	No
6b. If yes, which CA	High Street Conservation Area

7. Description
The ten-pane sash windows suggest an eighteenth century date but this building may have earlier origins; it has historic clay roof tiles.

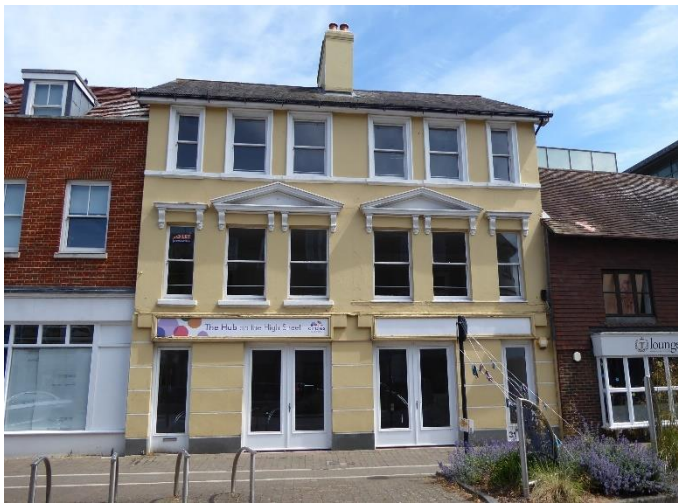
7. Description			
<p>This is a mid-nineteenth century building of neoclassical design. There are two central first floor pairs of windows with pediments on consoles, and the two other outer first floor windows have flat hoods on consoles. There is a string course to second floor cill level. The sash windows survive in the first and second floors but the doors and windows at ground floor appear to have been replaced to facilitate commercial units.</p>

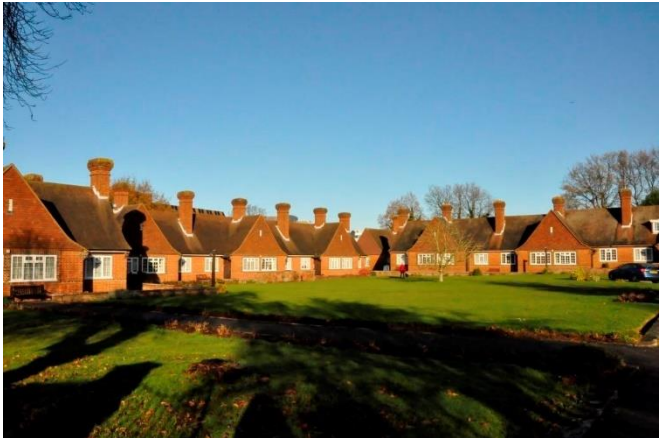
1. Name	The Dyers

2. UID	NG 04			
3. Address	The Dyers Almshouses, Northgate Road,			
4. Postcode	RH10 1YD			
5. Grid Ref	E: 526994 N: 137036			
6a. Conservation Area	Yes	<input checked="" type="checkbox"/>	No	
6b. If yes, which CA	Dyers Almshouses Conservation Area			
7. Description				
<p>Thirty Almshouses constructed by the Dyers livery company of London from 1939, designed by architects Bertram and Co. in the Arts and Crafts style. Arranged around a central quadrangle, the buildings have prominent gable ends with large decorative chimneys, tile-hanging, Tudor-style doors and red brickwork. Reminiscent of rural Dutch cottage style. Erected by local building firm Longleys. The first block was completed in 1940, a further sixteen houses were erected in 1952 and a final four in 1971.</p>

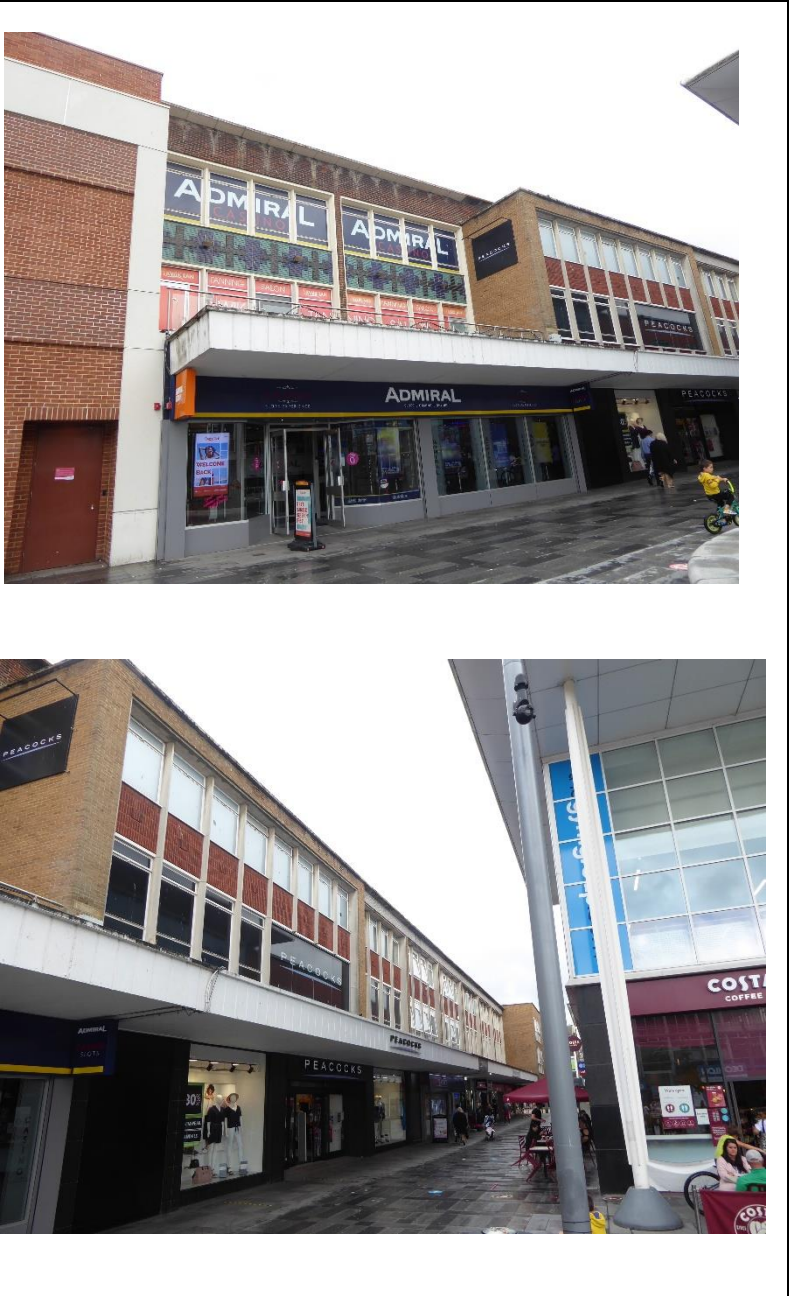
7. Description				
<p>Numbers 30-40 Queen's Square are set over three floors with shops under a suspended canopy at ground floor level. The windows of the upper two floor are set back within the elevation and vertically separated by vertical posts of Portland stone, with a brick detailing beneath each window.</p> <p>No. 40 occupies the corner plot where Queen's Square meets The Broadway. It projects beyond the building line of Nos. 30-39, and the shops are recessed under a colonnade supported by mosaic columns. The fenestration detailing of number 40 differs to the rest of the row, with a simple three over three individual glazed units formation.</p> <p>Within suggested New Town Centre ASLC (recommended for Conservation Area designation).</p>

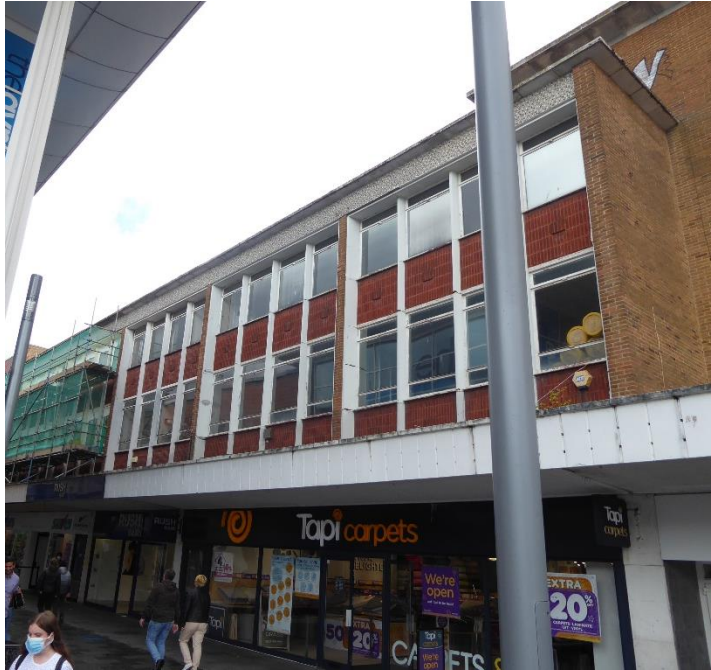
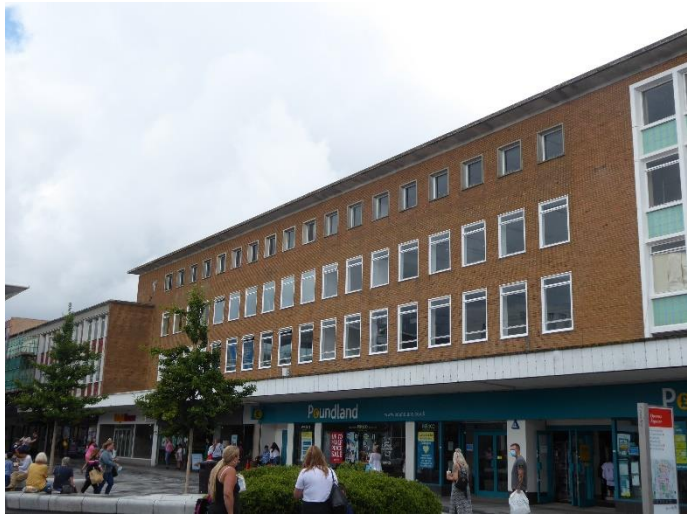
1. Name	4-19 Queen's Square		
2. UID	NG 06		
3. Address	4-19 Queen's Square, Crawley		
4. Postcode	RH10 1DY		
5. Grid Ref	E: 526950 N: 136718		
6a. Conservation Area	Yes	No	x
6b. If yes, which CA

Numbers 4-11 are set over three floors with shops under a suspended canopy at ground floor level. The windows of the upper two floors are set back within the elevation and vertically separated by Portland stone posts, under each window is a brick detailing. Above the third-floor windows is a mosaic frieze that stretches the full length of the elevation.

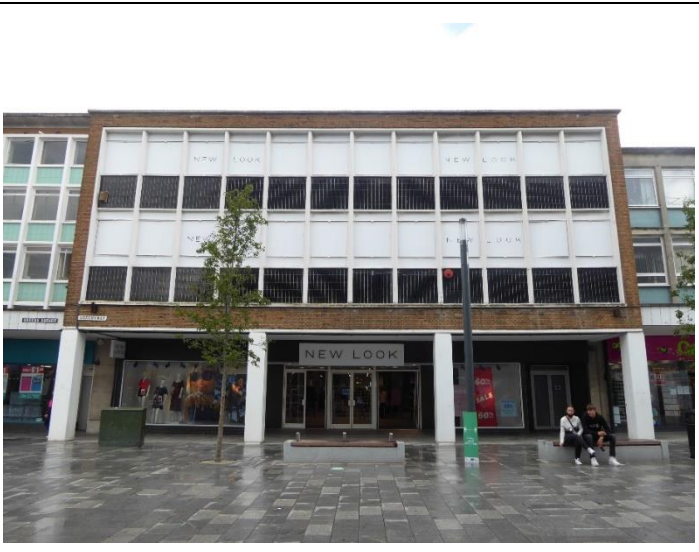
7. Description			
<p>The building is set over three storeys. The upper two floors are constructed in red brick with recessed shops at ground floor level. The colonnade is supported by square, concrete columns with a brick frieze. The front elevation has a glazed and ceramic element which is set in the front façade, and it is divided into vertical and regular panels with glazed ceramic tiles under the windows.</p> <p>Within suggested New Town Centre ASLC, recommended for Conservation Area designation.</p>

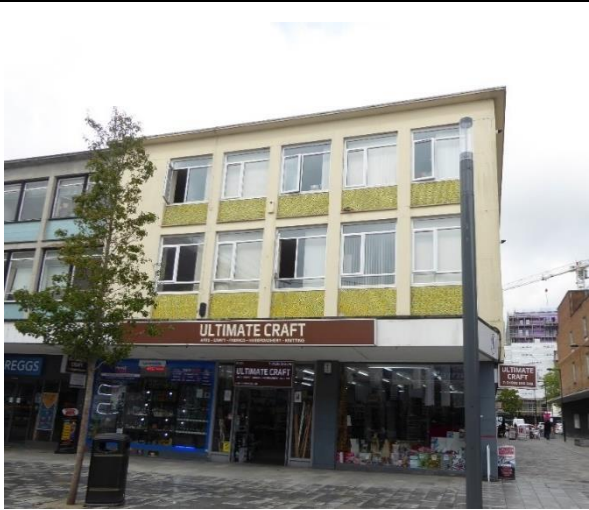
7. Description			
<p>The building is set over three-storeys and is four lights wide. The lower ground is occupied by shops with a suspended canopy. The upper two floors appear to be reinforced concrete, the windows are separated by vertical concrete posts, and directly below each window is a mosaic element.</p> <p>Within suggested New Town Centre ALSC (recommended for Conservation Area designation).</p>

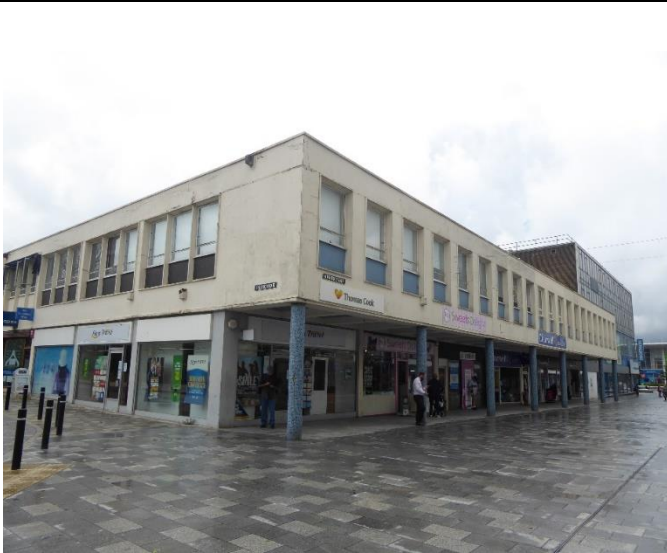
7. Description				
<p>Numbers 6-18 Queensway is a row of two-storeys with shops at ground floor level which are recessed under a colonnade. The columns are in blue tiled mosaic the underside of the colonnade are recessed elements which are also tiled mosaic. This row of shops was constructed as part of Crawley's New Town Development forming the central area for commerce.</p> <p>Within suggested New Town Centre ALSC (recommended for Conservation Area designation)</p>

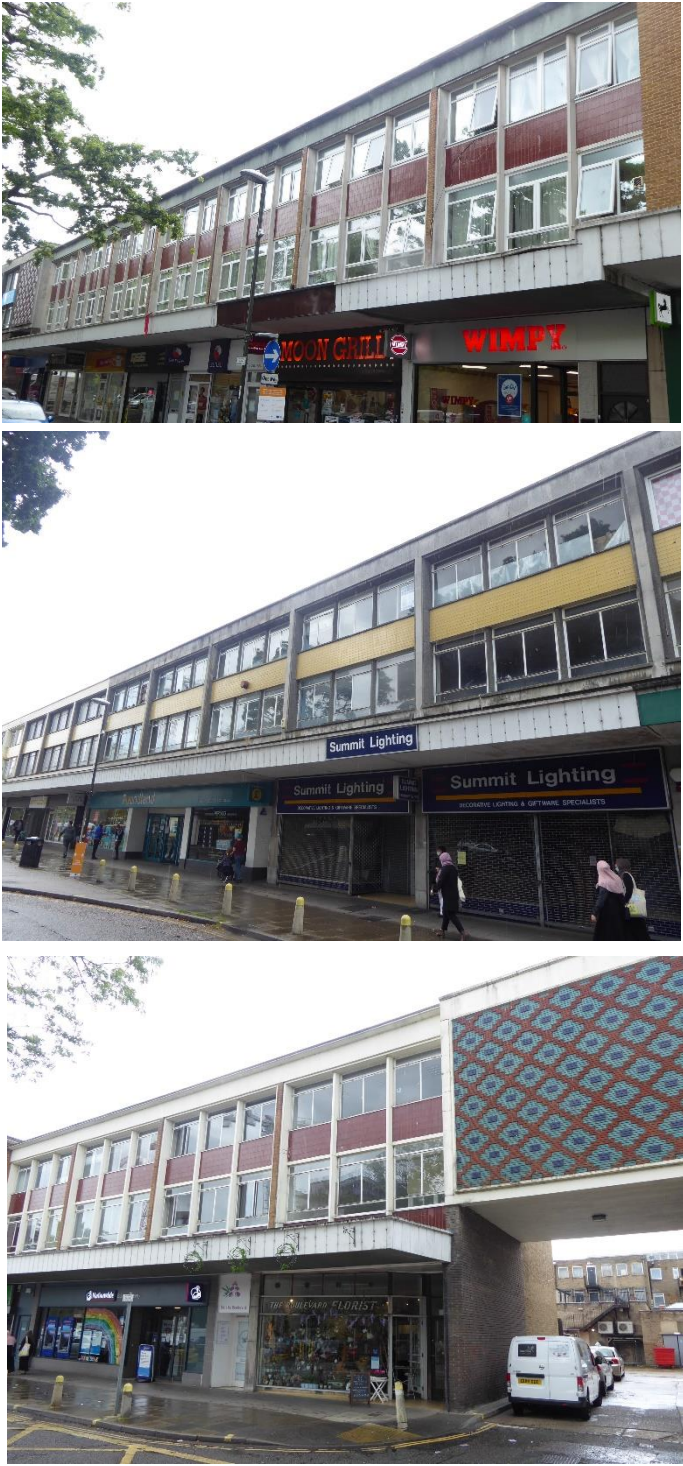
1. Name	20 - 62 The Boulevard			
2. UID	NG 10			
3. Address	20 The Boulevard Crawley			
4. Postcode	RH10 1XP			
5. Grid Ref	E: 526934 N: 136768			
6a. Conservation Area	Yes		No	X
6b. If yes, which CA

7. Description				
Number 20-62 forms part of a row of post-war shops which were all built in a similar architectural style, with shops to lower ground and typical mid-twentieth century fenestration detailing to the upper two floors.

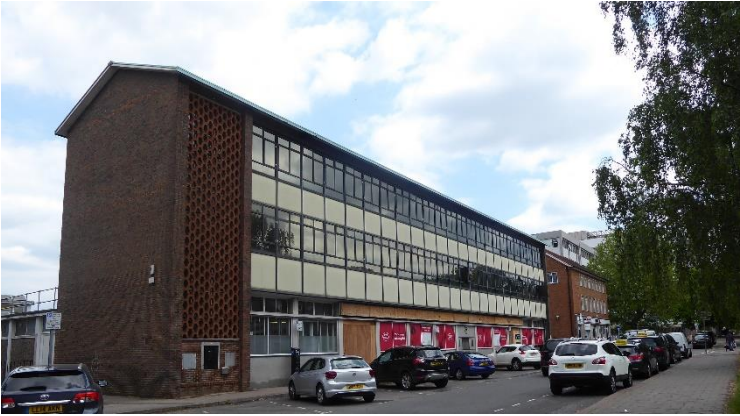
1. Name	Post Office			
2. UID	NG 11			
3. Address	Post Office, The Boulevard, Northgate			
4. Postcode	RH10 1AA			
5. Grid Ref	E: 526916 N: 136842			
6a. Conservation Area	Yes	<input type="checkbox"/>	No	X
6b. If yes, which CA

7. Description				
<p>Large, three-storey building with a dominant front and short flank elevation. The front elevation is predominantly glazed with a slight recessed ground floor and a honey-comb brickwork screen concealing a staircase at one end. It has a duo pitched copper roof. The building is set back from the main Boulevard.</p>

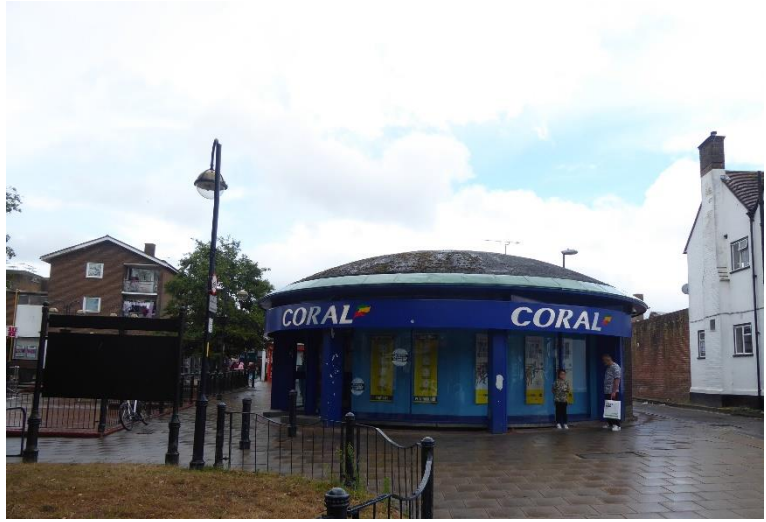
1. Name	2 Broadwalk

2. UID	NG 12			
3. Address	2 Broadwalk Crawley			
4. Postcode	RH10 1HQ			
5. Grid Ref	E: 526798 N: 136665			
6a. Conservation Area	Yes	<input type="checkbox"/>	No	
6b. If yes, which CA				
7. Description				
<p>Number 2 The Broadwalk is a drum shaped structure with a segmental domed roof with copper trim. The front elevation has a shop front supported by steel columns, and to the rear the walls are constructed from brick.</p>

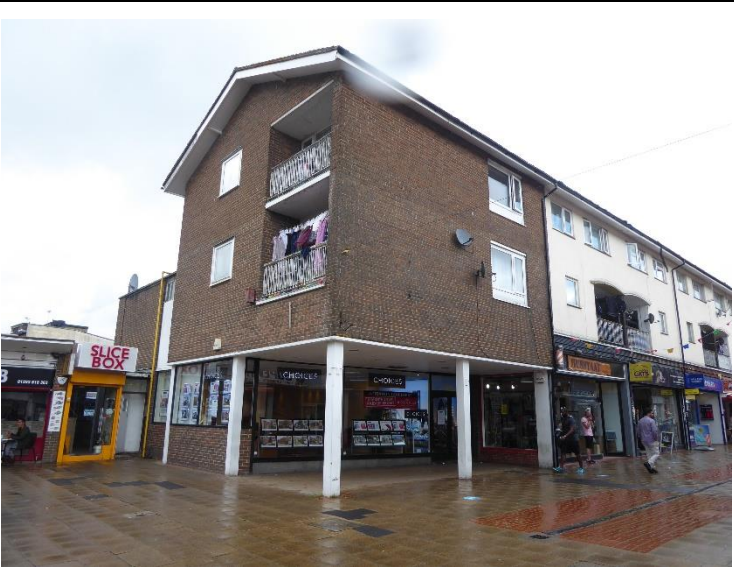
7. Description				
<p>Number 5 The Broadwalk is a three-storey building constructed from brick. There is a shop to the lower ground which is recessed under a colonnade supported by concrete columns. The upper two floors are occupied by residential flats with inset balconies in the west (high street facing) elevation.</p>

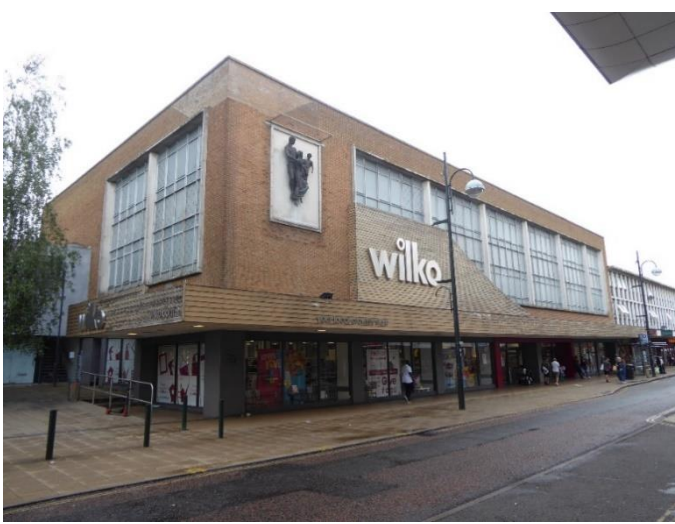
7. Description				
<p>Nos. 14-26 are currently occupied by Wilkos. The lower ground is covered by a thick suspended canopy which was refurbished in 2012. The glazed curtain walling to the front elevation is set back within the elevation and divided into six sections with Portland stone features. The south flank elevation has the same fenestration detailing. The upper two floors are constructed from brick and frames the fenestration detail. The south side of the front elevation has a 'Family Group' sculpture set on Portland stone.</p> <p>Within suggested New Town Centre ASLC (recommended for Conservation Area designation).</p>

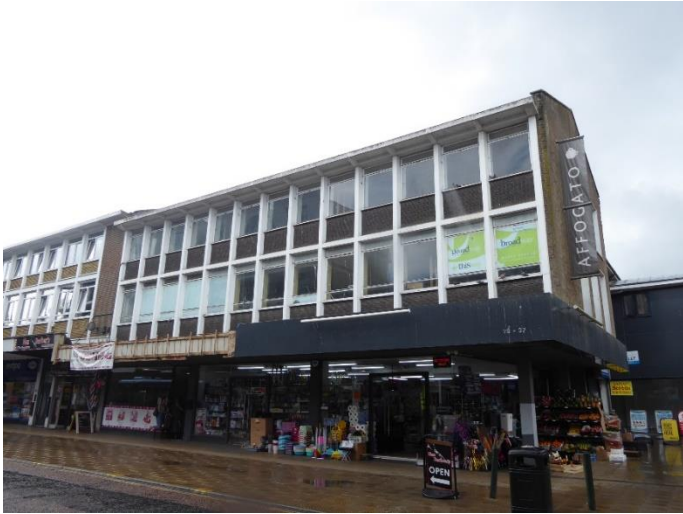
1. Name	28-32 The Broadway		
2. UID	NG 15		
3. Address	28-32 The Broadway Crawley		
4. Postcode	RH10 1HG		
5. Grid Ref	E: 526895 N: 136636		
6a. Conservation Area	Yes	<input type="checkbox"/>	No <input type="checkbox"/> X
6b. If yes, which CA

7. Description			
<p>Three-storey building with duo pitched roof. The lower ground is occupied by shops that are covered by a suspended canopy. The fenestration detailing is a typical post-war design divided by vertical Portland stone posts with glazed ceramic tiles beneath the windows.</p>

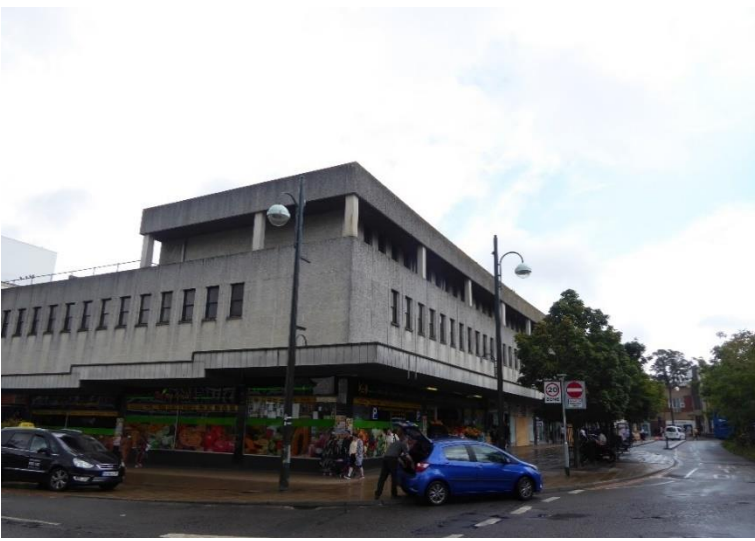
1. Name	Cross Keys House

7. Description				
<p>This building is a substantial and characteristically blocky in mass, constructed in the Brutalist style.</p> <p>The lower floor is occupied by shops which is covered by a suspended canopy. The east elevation (facing The Broadway) is stepped down.</p> <p>Nos 31-35 are set over two storeys and Nos 12-24 are set over three storeys. The upper two floors have simple sash windows which are relatively small for the scale of the building, creating a repeated pattern. The third floor is recessed under a projecting canopy supported by concrete block columns. The canopy is steps down along the west elevation.</p> <p>Within suggested ASLC - New Town Centre (recommended for Conservation Area designation).</p>
