Appendix A1 Non-designated Heritage Asset Review Local Heritage List

Crawley Borough Council

December 2020

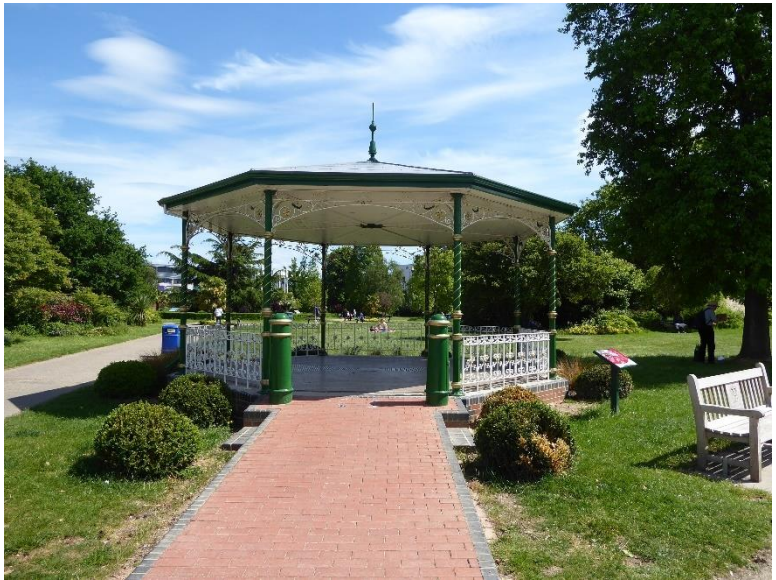
7. Description				
<p>Built in 1891, this was originally the bandstand for Gatwick Racecourse. The racecourse was built after Queen Victoria banned all race meetings in London during the 1880s because of hooliganism. The last race meeting was held in 1948 and the racecourse is located where Gatwick Airport was developed. In 1948 the bandstand was sold to Crawley Development Corporation for £60. It was refurbished and re-erected in 1958, when Her Majesty Queen Elizabeth II opened the Square, following her official opening Gatwick Airport.</p> <p>The bandstand was disassembled and removed from Queen's Square in June 2016 and was refurbished and moved to the Memorial Gardens in June 2018.</p>

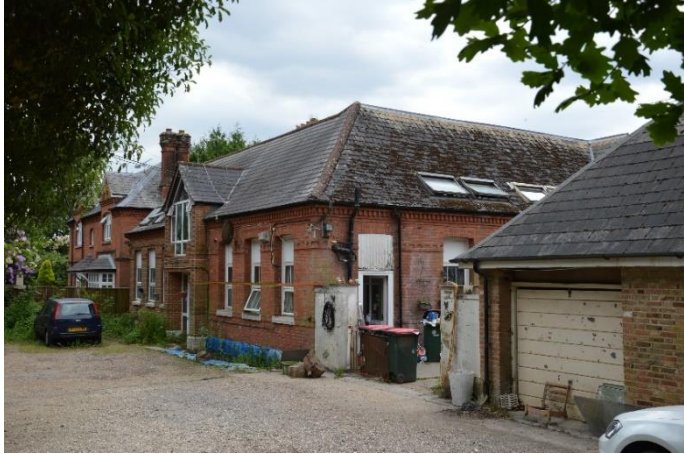
1. Name	The Moat House		
2. UID	PH 01		
3. Address	The Moat House, Balcombe Road, Pound Hill		
4. Postcode	RH10 7SY		
5. Grid Ref	E: 529659 N: 137423		
6a. Conservation Area	Yes	No	X
6b. If yes, which CA

7. Description			
<p>Late Victorian building with later alterations. The building adjacent to the south known as Woodways which was historically a Free School for girls. Following the end of Woodways use as a school with the addition of the structure known as the Moat House, the two buildings were in use as the laundry for the Worth Park Estate. The building is now in residential use. Moat house features an unsympathetic modern gable extension and a large three bay garage that detracts from the form and materiality of the pair of buildings. Observation and photography were challenging for the building known as Moat House. Moat House is attached to the building next door to the south known as Woodways.</p>

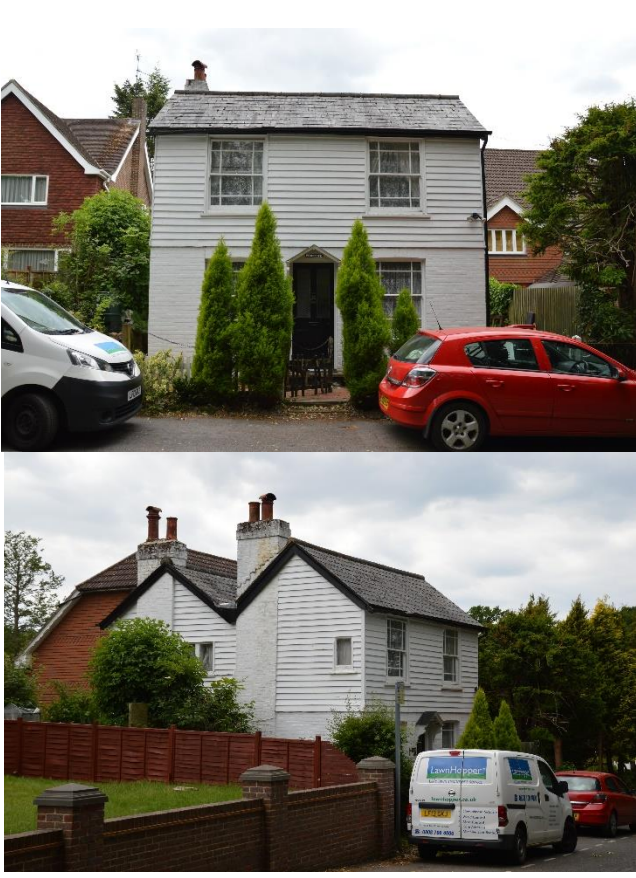
1. Name	Woodcote Cottage

2. UID	PH 03			
3. Address	Woodcote Cottage, Crawley Lane			
4. Postcode	RH10 7EG			
5. Grid Ref	E: 529550 N: 136978			
6a. Conservation Area	Yes	No	X	
6b. If yes, which CA				
7. Description				
<p>An attractive detached 1840s cottage of two storey and two bays with a gabled m-roof. The ground floor consists of solid red brick but has been painted since the original local list description was written. The first floor external walls are weather boarded. The building retains original sash windows with margin panes.</p>

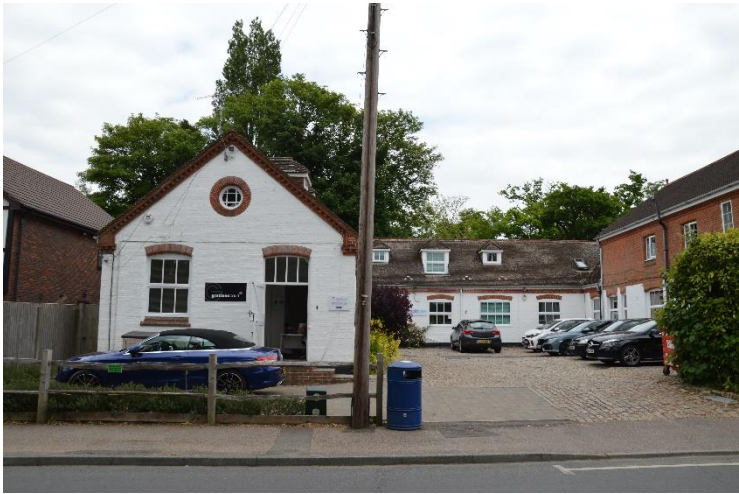
7. Description			
<p>The former stable blocks of Park Farm which was associated with Worth Park House. The building is U-shape in footprint. The property is set over one and a half storeys with hipped dormers to the roof pitch. The building is constructed from brick painted white. Decorative features include arched lintels in red brick, dog tooth dentils and the gable front facing the road has an oculus window.</p> <p>Stone sets to the forecourt/courtyard appear to be original and should be retained. They contribute to the character of the group of former farm buildings, allowing for a continued understanding and appreciation that this was once a working farm within a more rural surrounding.</p>

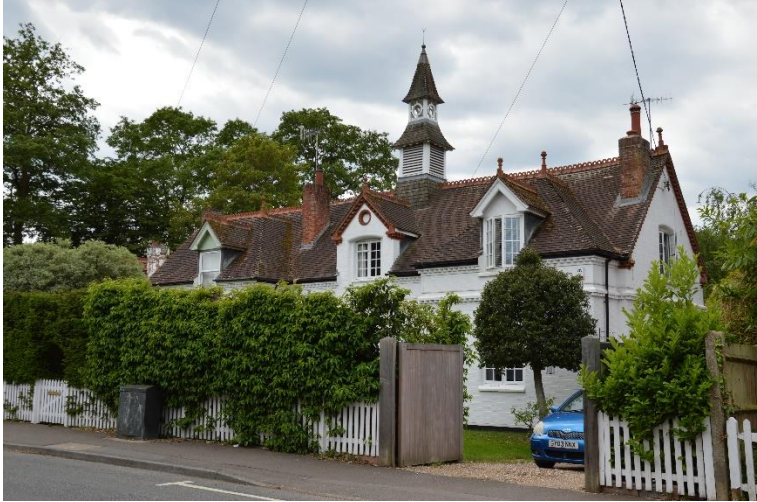
7. Description
<p>Architecturally impressive mid-Victorian farm building, part of a former farmstead known as Park Farm associated with Worth Park House (now demolished).</p> <p>57-59 Grattons Drive is converted into a terrace of three houses. The building is likely to be of red brick construction with bricks laid in Flemish bond, however it has been painted white since the local list description was first written. The building features two protruding bays flanking a central doorway with gabled dormer above. The eaves and string course below it are articulated with brick dentils, broken in three places on the eastern elevation by the three gabled dormers. The centre of the plain clay tile is dominated by a two-tier decorative oak shingle ventilation tower. The roof line is capped in decorative clay ridge tiles the gables featuring decorative terracotta finials. The central gabled dormer features dentil eaves course and an oculus above the window. Some of the chimneys may be later additions dating from the building's change of use, some pots to the chimneys remain. The building is glazed in a variety of window styles of timber and UPVC with some large and some small paned windows.</p>

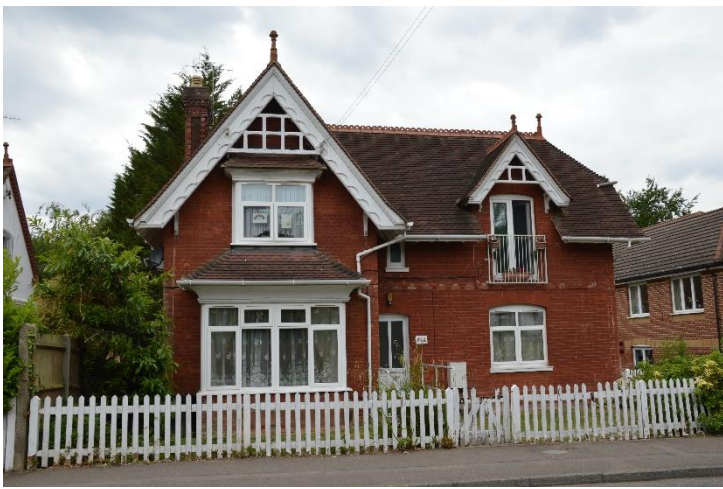
1. Name	61A Grattons Drive		
2. UID	PH 08		
3. Address	61A Grattons Drive, Crawley		
4. Postcode	RH10 3AG		
5. Grid Ref	E: 529207 N: 137958		
6a. Conservation Area	Yes	No	x
6b. If yes, which CA

7. Description			
Two-storey picturesque property in an L-shape form with half hipped roof to side elevation and a gable end and eve dormer to the front elevation. Decorative barge board with timber decorative bracing truss to the gable pitch. The roof has red clay tiles with crested clover leaf ridge tile and ball top finials.

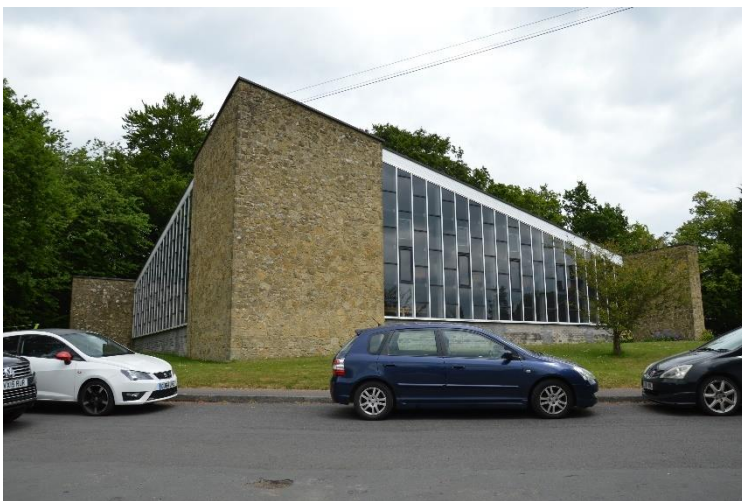
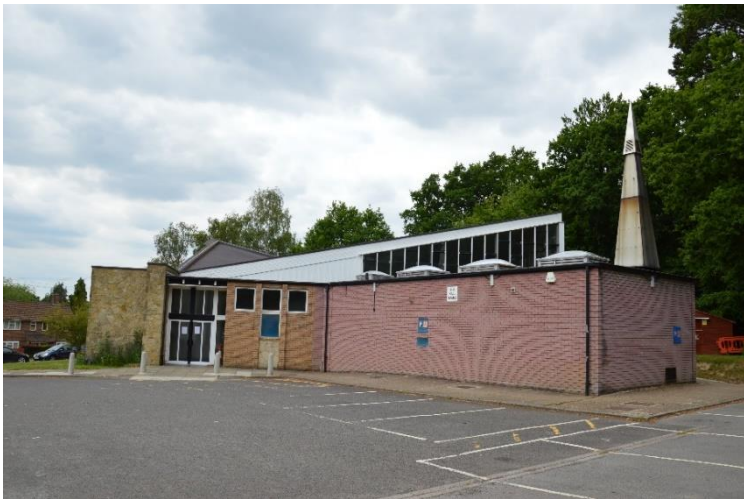
1. Name	RC Church of Edward the Confessor		
2. UID	PH 09		
3. Address	RC Church of Edward the Confessor, Hillcrest Close		
4. Postcode	RH10 7EQ		
5. Grid Ref	E: 529687 N: 136880		
6a. Conservation Area	Yes	No	X
6b. If yes, which CA

7. Description
 Designed by Alexander Lane and built in 1965 on land given by the Crawley Development Corporation.

Reinforced concrete, and faced with smooth rubble limestone. The plan is of two triangles, the church hall/clubroom, back to back, the high points of the catenary roof being the two furthest apart. The church faces south with the altar set at the outermost point of the triangle. The two side walls are largely glazed causing interior problems of solar gain and glare for the congregation facing the altar. The entrance is at one end of the spine wall.

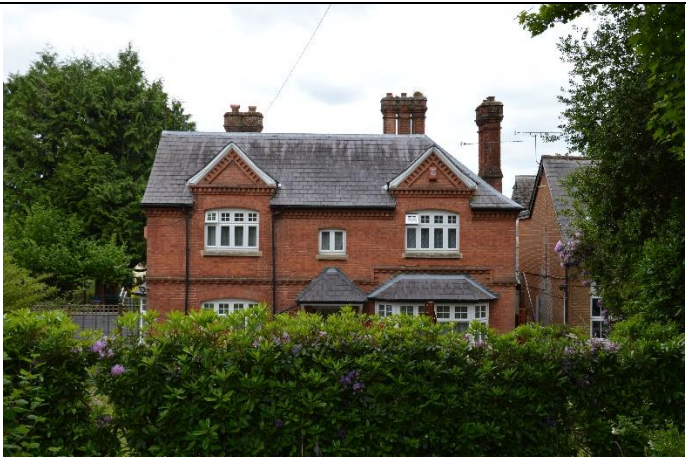
7. Description				
Late Victorian historically a Free School for girls. Latterly, the building was in use as part of the Worth Park laundry. Now in residential use.

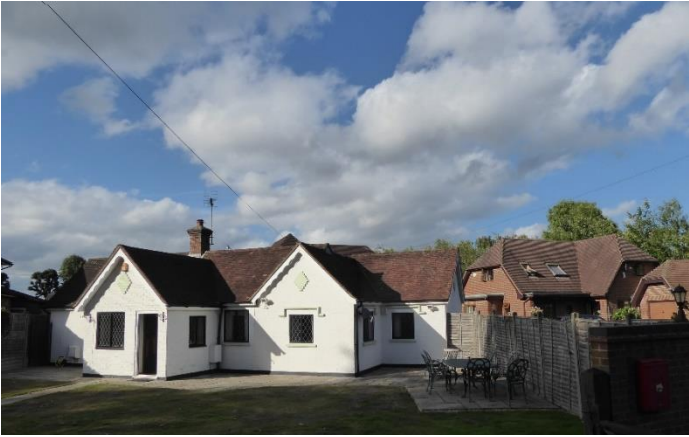
7. Description			
<p>Caxton's Lodge is the former gate lodge to Crabbet Park which is a Grade II* listed manor house. It is a single storey property in painted brick under red clay tiled roof. The earliest reference to Crabbet Park was in 1296. Crabbet Park House was constructed in 1873 and Caxton's Lodge is likely to be contemporary with the principal house.</p>

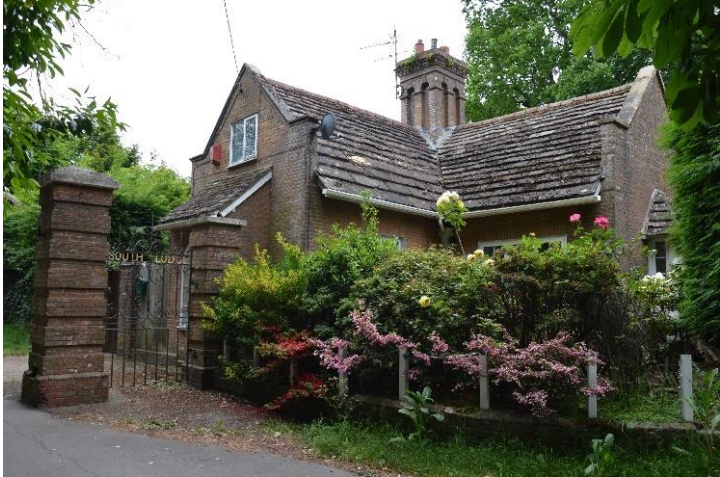
7. Description				
<p>This is a small compact red brick lodge, cruciform in plan, with Dutch end gables and a heavy decorative central chimney stack. This is a good example of the use of graded Horsham slab as a roofing material. Located adjacent to an historic drive to that historically led to Crabbet Park. The gate lodge features a low sweeping wall to its front, following the curve of the drive round from Crawley Lane to the drive. The sweeping wall terminates at the foot of one of three gate piers of brick construction with projecting and recessed courses. The pedestrian gate remains, though the main gates are lost.</p> <p>The roof features an area covered by a tarpaulin at the date of survey, the chimney also is in the process of biological colonisation. There is risk here that the building may deteriorate if these issues are not addressed.</p> <p>The building features a solar heating panel to a small outshot extension in the corner to the east and south ranges. This detracts from the appearance of the historic building.</p>

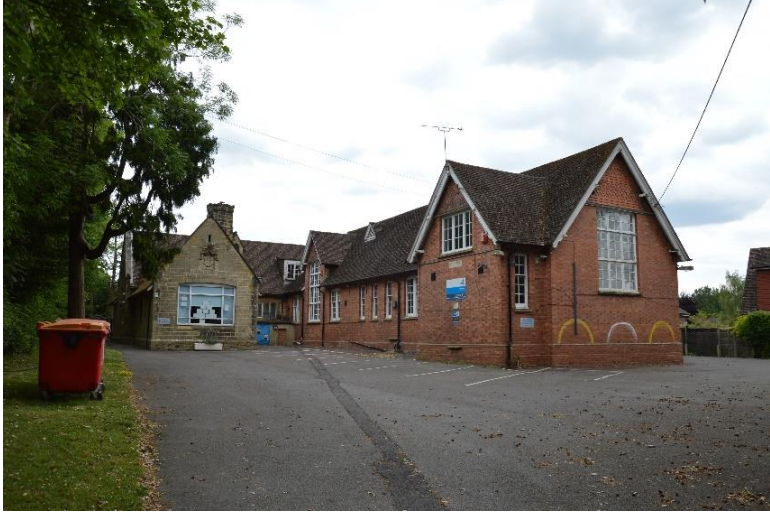
7. Description				
<p>A Victorian school constructed in two phases. The earlier phase dates from 1852 and uses graded cut sandstone blocks that contain decorative stone end gables. It has a sizeable decorative chimney stack adjacent to the bell tower with a castellated and corbeled parapet to the cap of the stack. The later extension dates from 1894 is of red brick in Flemish bond with darker headers, contrasting with the stretchers to produce a decorative variegated pattern to the wall. The 1894 extension also features prominent tile hung gable roofs with decorative fascia boards and retains large original windows in timber.</p>

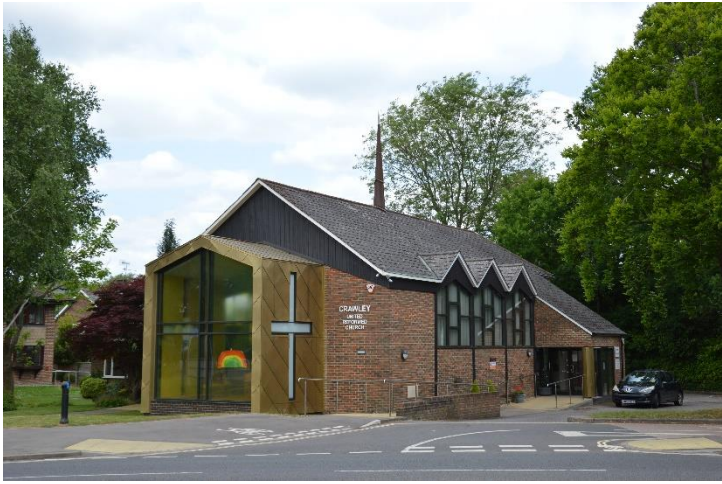
7. Description				
<p>Crawley Development Corporation provided this site for a Congregational (later United Reformed) church. Christ Church was designed by Lomas and Pooley and opened in 1957. The building is constructed in red brick with an adjoining hall on its west side. Careful detail has been considered and applied in the design of this church; for example, a fleche pattern is created in the weatherboarding above the side windows which is repeated in the gable end of the main building. The building is of a good example of a nonconformist church created with the redevelopment of Crawley as a new town.</p> <p>A previous single storey brick front porch to the south gable has been replaced by a taller zinc clad extension with full height glazing. Original windows have been replaced.</p>

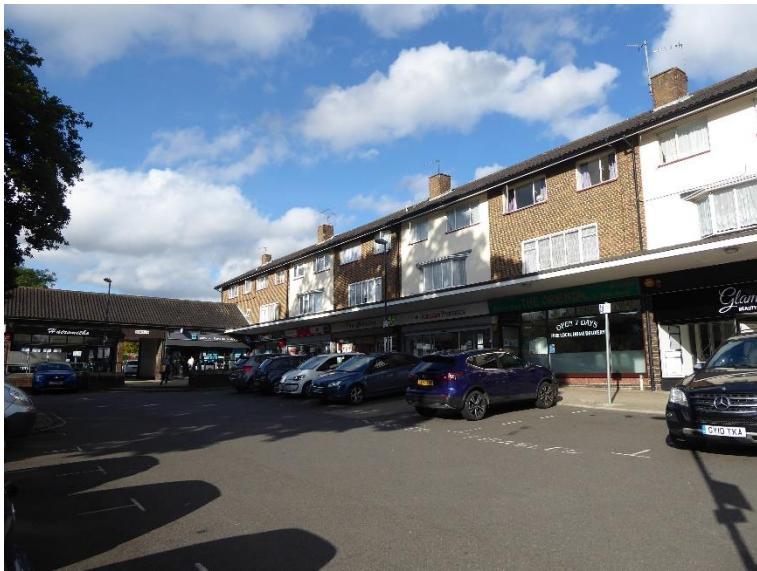
7. Description				
<p>A neighbourhood shopping parade that is typical of Crawley's New Town Development. The parade is set in an L-shaped form. The parade is set on the north-south axis and has shops to the ground floor with the upper two stories occupied by residential flats. The upper floors alternate between dark brick and render. Those that are rendered have canted bay windows to the first floor.</p> <p>The parade on the east-west axis is set over two floors with half of the parade occupied shops and the other half occupied by residential flats which are separated by a walkway through to Pound Hill Place.</p>

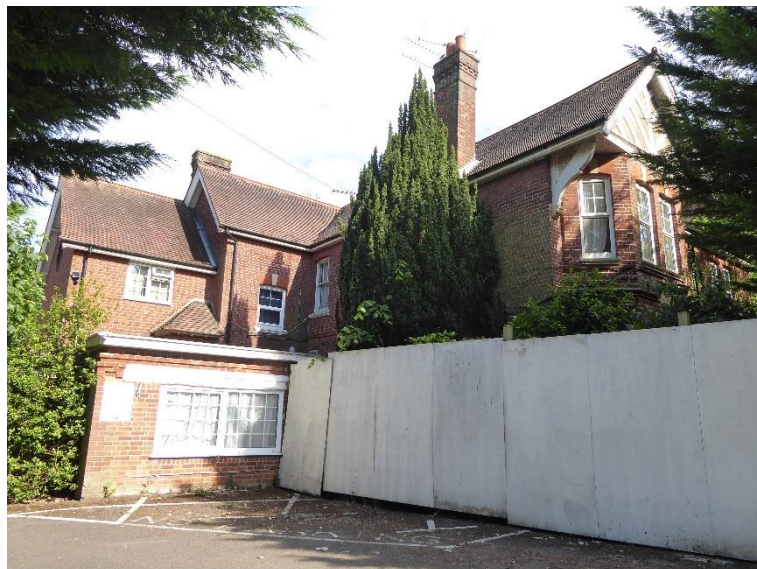
7. Description
<p>Large detached late-Victorian property, red brick, carved timber supporting bracket sat on a stone corbel, half-timber with roughcast render under gable fronts.</p> <p>Embedded stone with engraved 'Hazeldene 1896'</p> <p>If this property was well maintained it would contribute greatly to the streetscene, neighbouring No. 26 is also a large late-Victorian property and therefore as a pair they have a strong aesthetic value. There are also other good examples of Victorian properties along Brighton Road which uphold the character and appearance of the Conservation Area.</p>

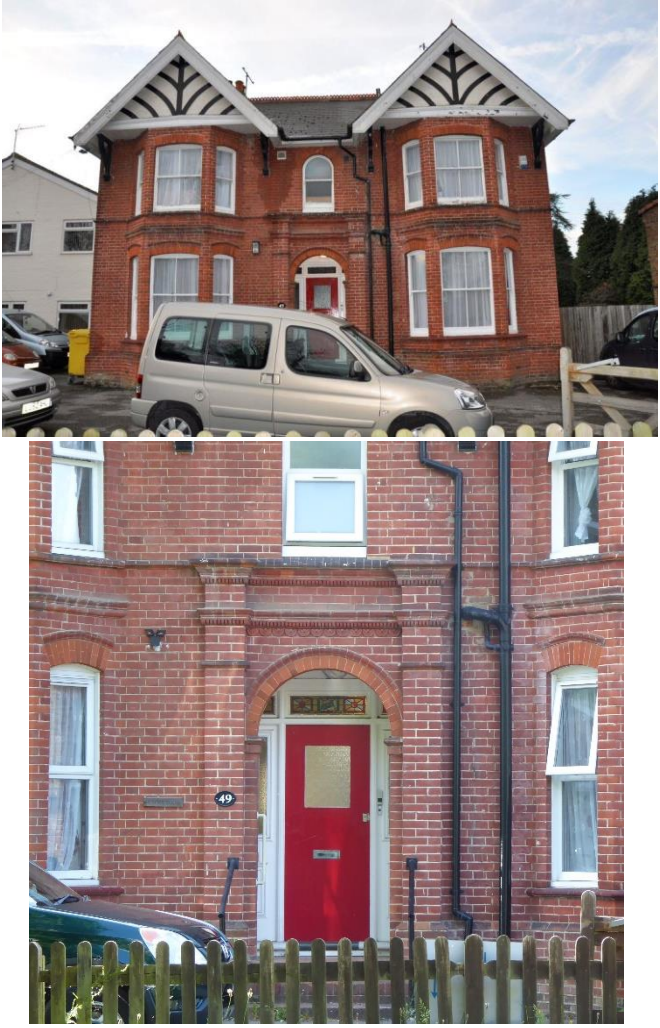
7. Description
Detached late Victorian or Edwardian villa, in red brick with high quality moulded brickwork, including pilasters flanking the porch. Timber framed gable ends, slate roof with decorative clay ridge tiles. Retains original 4- pane sash windows in double height bay windows, and stained glass in porch.

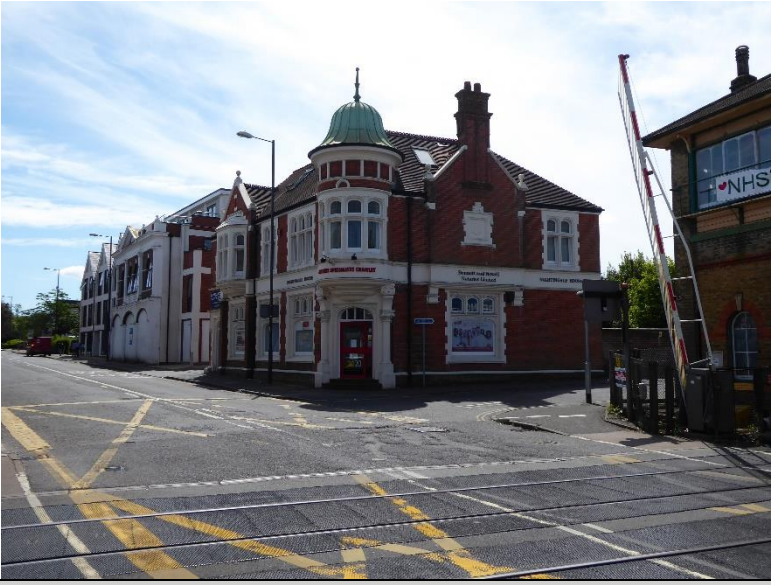
7. Description			
<p>This bank dates from 1901 and is constructed from red brick with stone detailing and a copper turret. The building has oriel windows at first floor level, with prominent gable ends, and a mixture neo-gothic and naturalistic classical detailing of the windows and doors at ground floor. It forms an important landmark on the corner of Brighton Road and Springfield Road, with a striking reverse ogee copper turret. This property was originally a bank.</p>

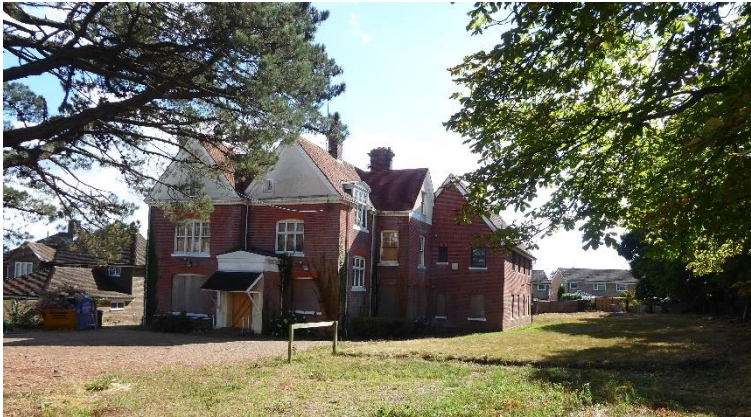
7. Description				
<p>A large, detached Edwardian Villa constructed as one of the first developments of Goffs Park Road. The property is set over three storeys and has two dominant gable fronts facing Goffs Park Road with large arched windows. The property is constructed from red brick laid in Flemish bond, with dentilled cornice and eaves under a red tiled roof. Beneath the gable the elevation is rendered in roughcast and painted, there is a simple sliding sash set within the gable of the third floor.</p>

10. Aesthetic / Architectural Value						
<p>This property is indicative of the area’s early twentieth century development. The property has attractive architectural features such as dentilled eaves, tiled roof, prominent chimney stacks and largely presents a traditional character from the front. However, the property has been unsympathetically extended to the rear cutting through the original form of the property. Original windows have also been unsympathetically replaced with modern uPVC. Despite the unsympathetic alterations the large property retains its architectural character and is pronounced within the streetscene. Careful repair and maintenance of the property would greatly enhance the character of the building.</p>

14. Landmark / Townscape Value							
N/A							
15. Archaeological Value							
N/A							
16. Overall Condition							
Good		Fair		Poor	X	Very Poor	
Unknown		Notes:	The property appears to be vacant				
17. Recommended for inclusion				Yes	X	No	
18. Date of assessment				18/08/20

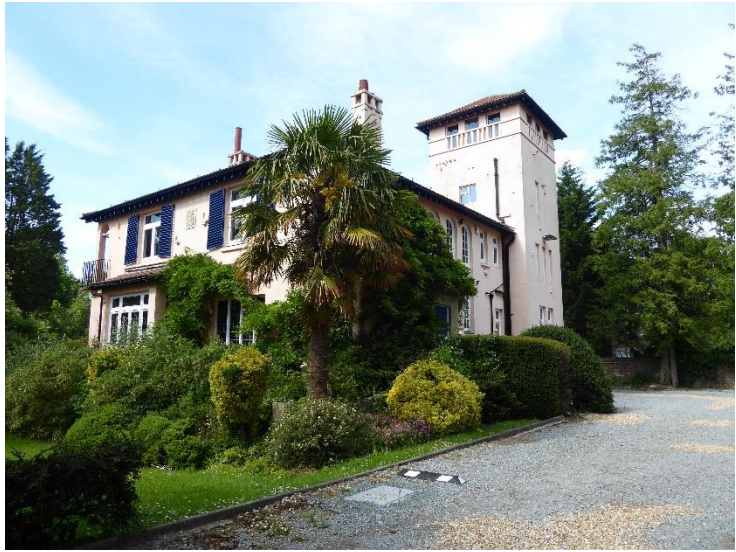
7. Description			
<p>This detached property was constructed in 1905 in the style of rustic Tuscan villa, stucco-faced painted pink. There is a tower to the rear, reminiscent of a campanile, which according to the existing local list description was conceived as service quarters. Both buildings have a heavily featured over sail of terracotta roof tiles. The chimney stacks and top of the tower have rectangular decorative features.</p>

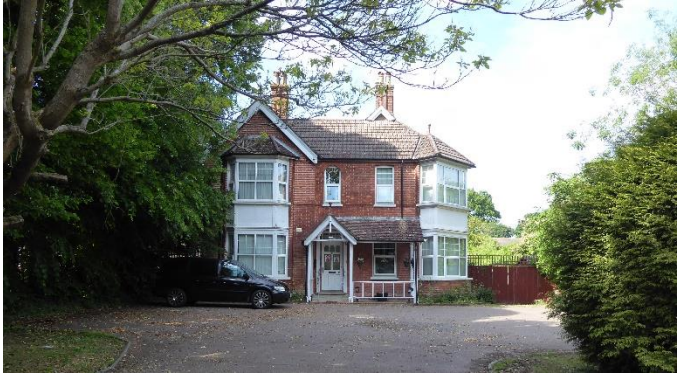
7. Description			
A late Victorian red brick villa. A number of features described in the original local list are no longer evident, including the decorative plaster band at first floor level and dentillated gutter soffits on the main end gable and fascia board. The windows have also been replaced with uPVC. The front entrance door has a moulded ceramic surround.

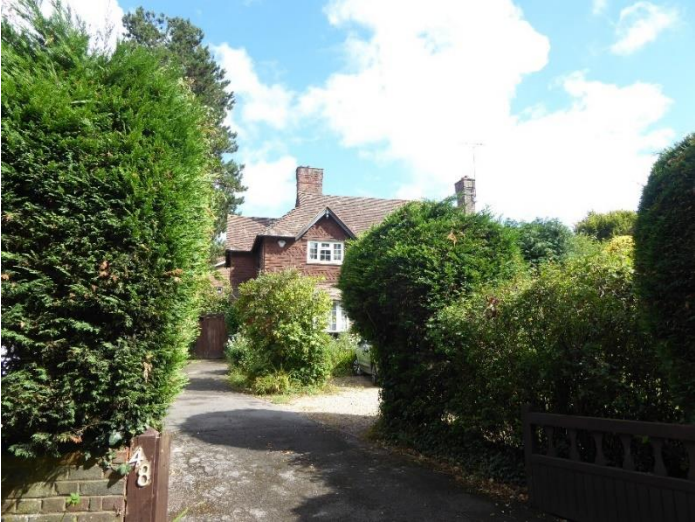
7. Description			
<p>This building is a large detached Arts and Crafts style property constructed between 1910 and 1932. It is situated on a corner plot and set back from the road. The property is two storeys in height with a Dutch hipped gable roof, with hung terracotta tiles, which prevail throughout Crawley. There are two tall, prominent chimney stacks located on the south and east elevation.</p>

10. Aesthetic / Architectural Value							
<p>The property is a typical example of an early twentieth century dwelling and displays the use of traditional materials and craftsmanship commonly associated with the Arts and Crafts movement. The property is located within a designated Area of Special Local Character which recognises the areas aesthetic and architectural value. This property is not an architecturally unique example in Crawley but does make a positive contribution to the area. The windows appear to be modern uPVC replacements which detract from the architectural and aesthetic character of the property.</p>

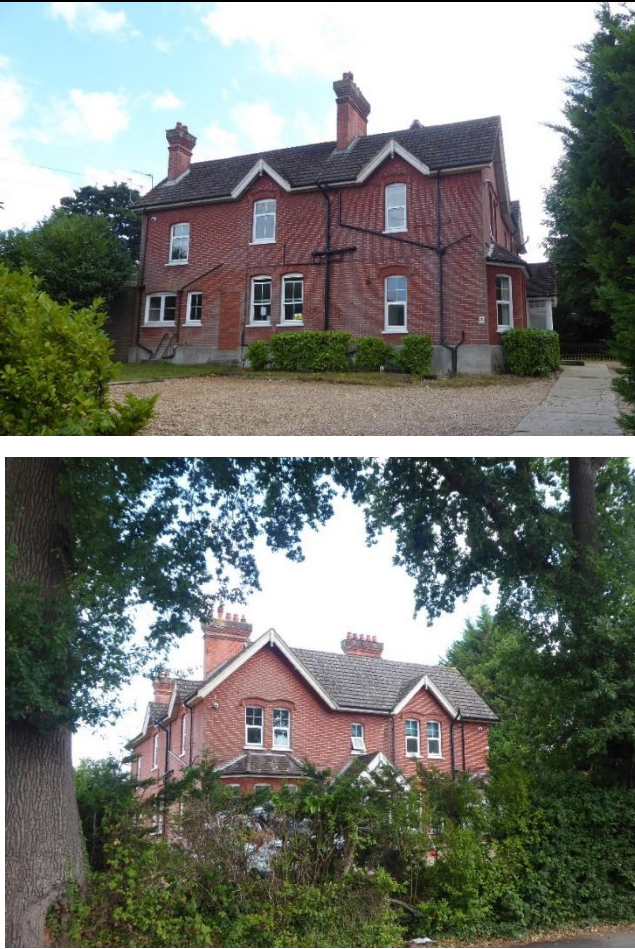
7. Description			
Large detached, Edwardian property constructed of red brick in stretcher bond. Prominent gable porch with decorative half-timber with rough cast above the entrance door. The windows at first floor level have attractive eyebrow lintels.

The building's windows appear to largely have been replaced with modern uPVC and the side entrance has been unsympathetically bricked up. Despite some modern alterations the property retains its architectural character and is indicative of Crawley's pre-war development.							
11. Historic Value							
N/A							
12. Social / Communal Value							
N/A							
13. Group Value							
N/A							
14. Landmark / Townscape Value							
N/A							
15. Archaeological Value							
N/A							
16. Overall Condition							
Good	X	Fair		Poor		Very Poor	
Unknown		Notes:					
17. Recommended for inclusion				Yes	X	No	
18. Date of assessment				18/08/20

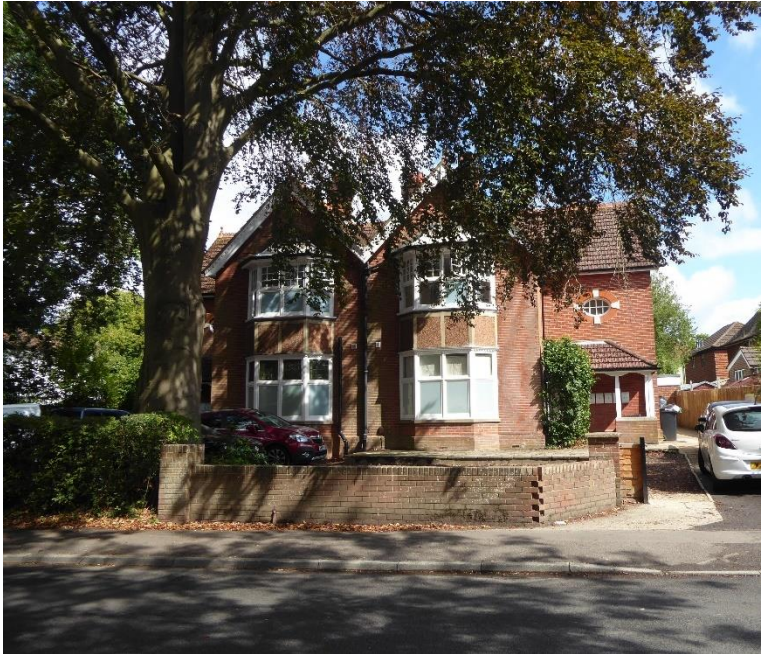
7. Description			
Semi-detached properties constructed between 1899 and 1910. The pair have imposing gable fronts and an asymmetric plan which mirror in design, creating a balanced form. The gable fronts have canted bays set over two storeys. The roof has red clay tiles and decorative terracotta ridge tiles. The properties have an oval oculus window each with six panes. There is a brick and timber porch to the recessed front elevation under a hipped roof.

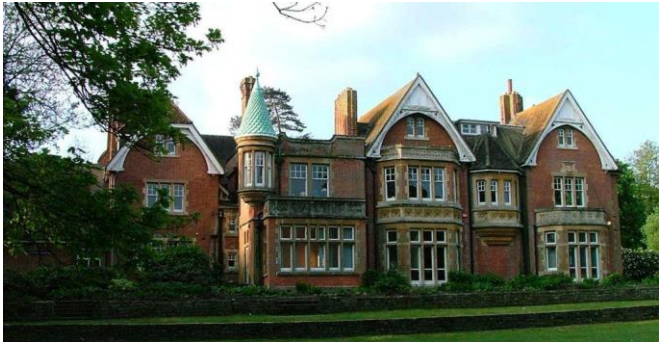
7. Description					
<p>Goffs Park House was a country house designed by the architect William Buck and completed in 1882. It was commissioned by the banker Edwin Henty and built by Messrs Peter and Redford of Horsham. This is a substantial stock red brick Victorian house in the Domestic Revival and Queen Anne style. There is a modern extension on the south-east side of the building. Most windows and dressings are original, although some dormer windows have been added in the top floor. The mullions and decorative entrance bay are of high-quality dressed sandstone, often with a foliage pattern. There is evidence of the survival of the original internal features including a staircase and fireplaces. The building is set in the historic landscape of Goffs Park, a locally listed park and garden. The garden includes a formal parterre and ornamental lake to the north. Goffs Park House is currently occupied by Crawley Museum and the Probation Service.</p> <p>There is a modern single storey side extension to the east elevation.</p>

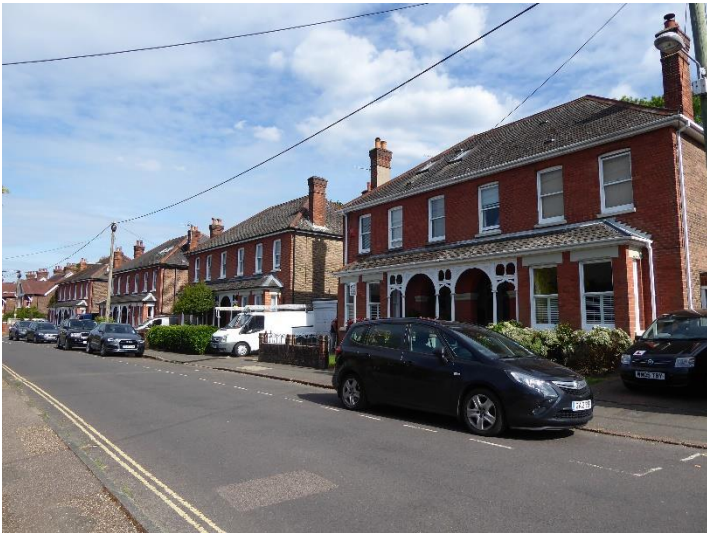
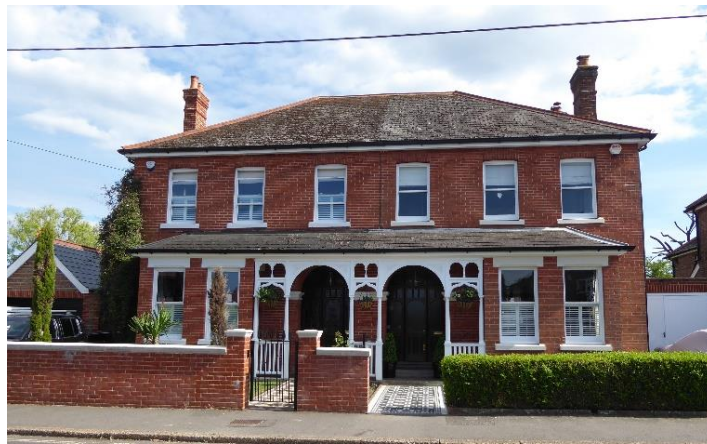
7. Description
This is a group of eight matching semi-detached houses built at the turn of the century. They are constructed of red brick, hipped roof and have square bay windows with single pane sash windows. All houses have decoratively carved wooden porches and many still have stained glass inserts in their triple panelled front doors.

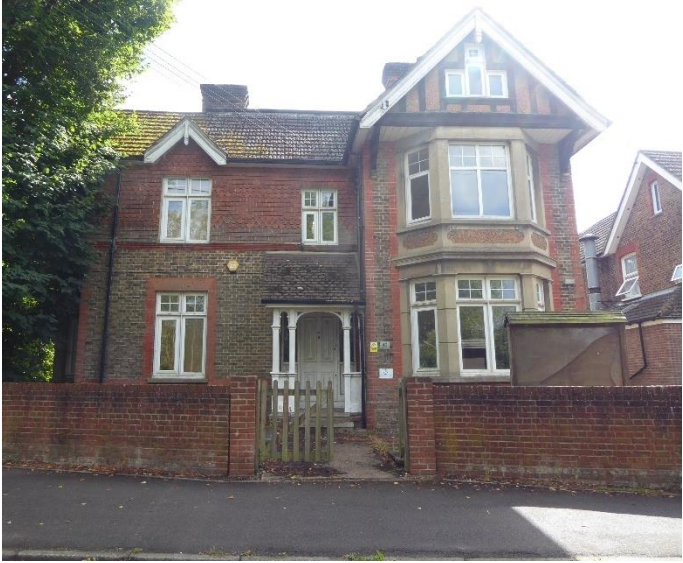
7. Description
Late nineteenth century detached property. The property has a dominant gable front with canted bays surrounded by stone. The property is constructed from brick laid in stretcher bond with quoin detailing and hung tiles to the first floor. There is a decorative timber porch presenting an attractive and traditional entrance.

10. Aesthetic / Architectural Value						
There have been some modern alterations to this property, such as the replacement of timber windows with modern uPVC and replacement roof covering. Nevertheless, the property is located on a prominent corner plot, retaining a strong nineteenth century character. Hung fishscale tiles can be seen on many of Crawley's nineteenth century properties and therefore relates to local style and identity. The property is an attractive late nineteenth century property and makes a positive contribution to the character of Springfield Road.

13. Group Value							
N/A							
14. Landmark / Townscape Value							
N/A							
15. Archaeological Value							
N/A							
16. Overall Condition							
Good		Fair	X	Poor		Very Poor	
Unknown		Notes:	Property appears to be vacant				
17. Recommended for inclusion				Yes	X	No	
18. Date of assessment				18/08/20

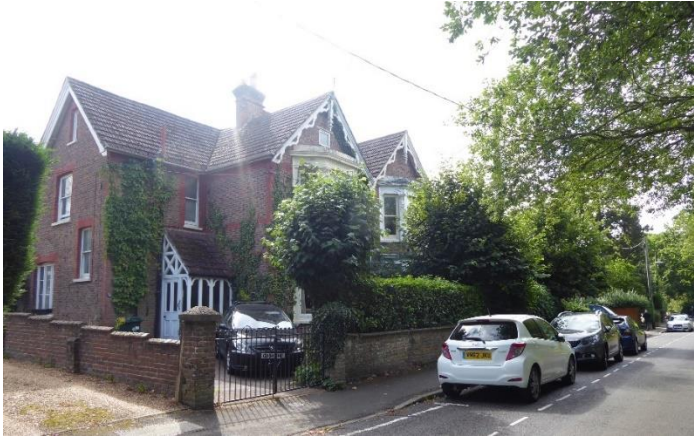
7. Description				
A pair of two-storey semi- detached houses, late nineteenth century. Constructed in dark brick with red brick quoin detailing. Prominent gables to the front elevation with decorative barge boards. The properties have canted bay windows with stone surrounds which extend over two floors. The properties also have attractive timber porches.

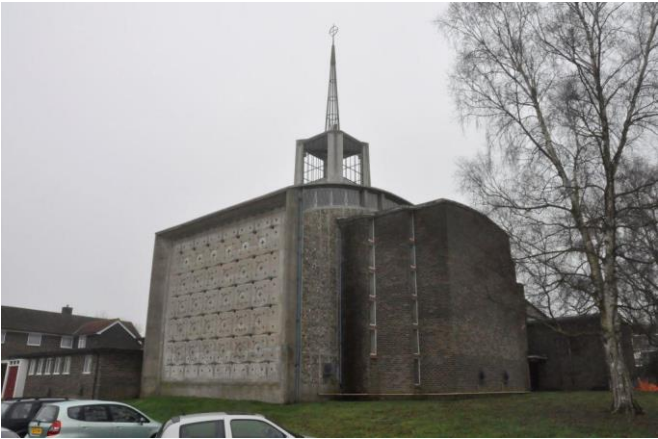
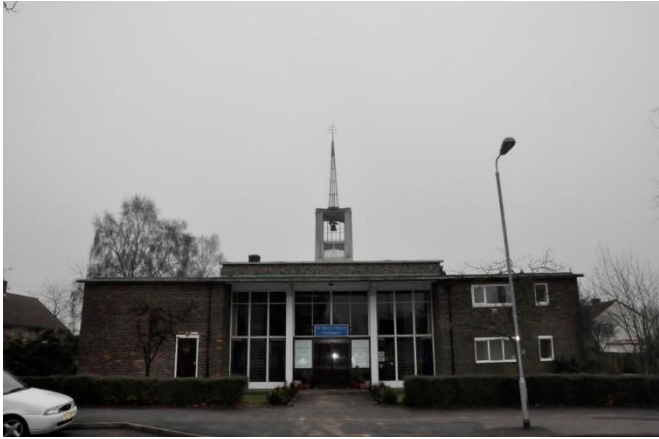
2. UID	SG 17			
3. Address	St Marys Church, Wakehurst Drive,			
4. Postcode	RH10 6DL			
5. Grid Ref	E: 527060 N: 135581			
6a. Conservation Area	Yes	X	No	
6b. If yes, which CA	Southgate Neighbourhood Centre Conservation Area			
7. Description				
<p>St. Mary's Church was completed in 1958 as part of the development of the New Town neighbourhood centre at Southgate and was designed by Braddock & Martin-Smith. It is constructed in reinforced concrete clad in flint and brick, with a sweeping hump-backed roof surmounted by a skeletal lantern tower and flèche. The east wall forms a decorative concrete reredos. Steel and concrete structure bell tower with the hall located at the west end of the nave.</p>

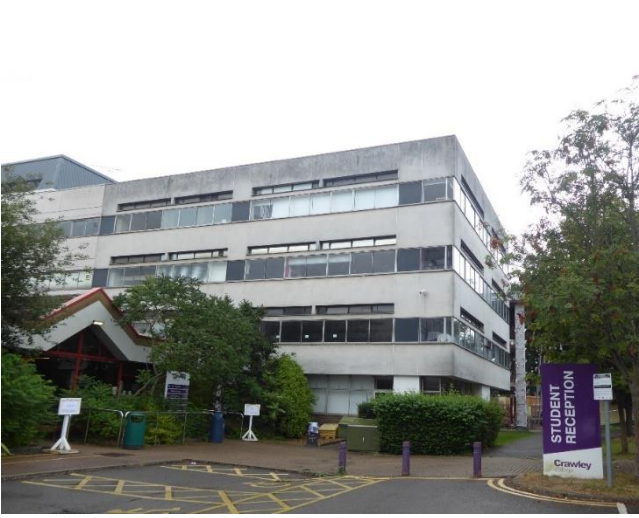
7. Description				
<p>Crawley College was opened by HM Queen Elizabeth in June 1958. This building is part of a group of New Town buildings that form Crawley College Campus. The building is a four-storey building set on an east-west axis with a cubic form in a Brutalist style. It is constructed from reinforced concrete with large glazing to each floor.</p>

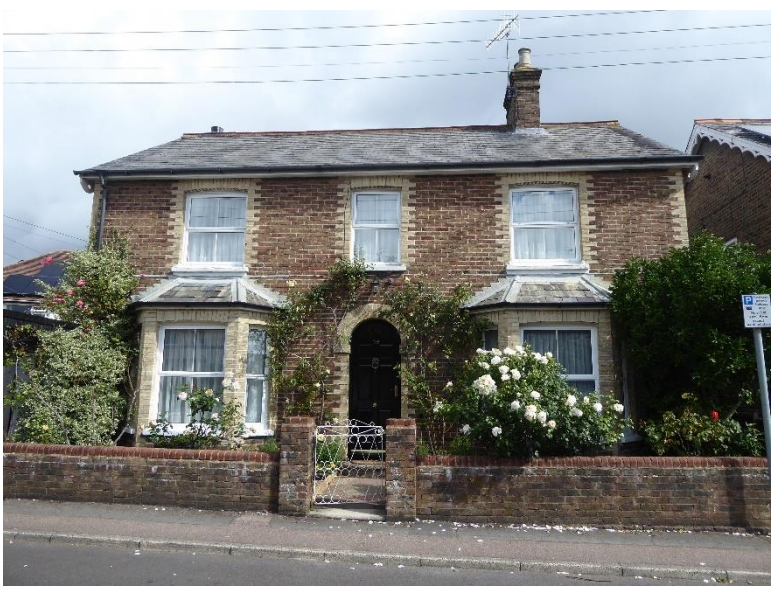
7. Description			
<p>Late nineteenth century property. Two-storey gable ended dwelling, three bays wide with a central entrance door with an arched lintel. Two bay windows with hipped roof flank the entrance door. The property is in brick with light brick quoins and window surrounds. The gable ends have carved barge boards which can be seen on a number of houses within the area.</p> <p>Within suggested Hazelwick Road Conservation Area extension.</p>

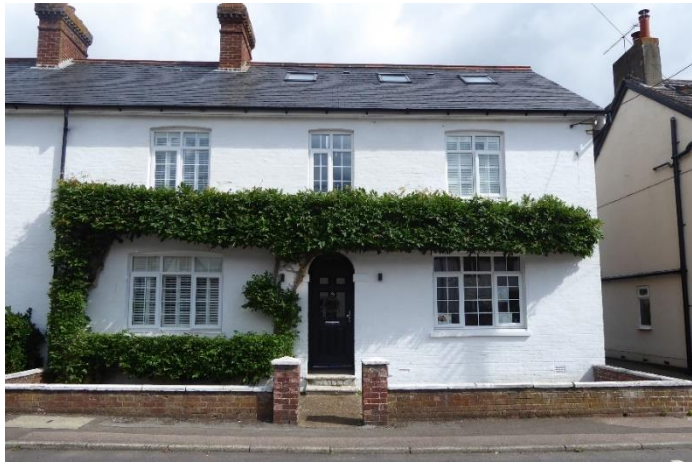
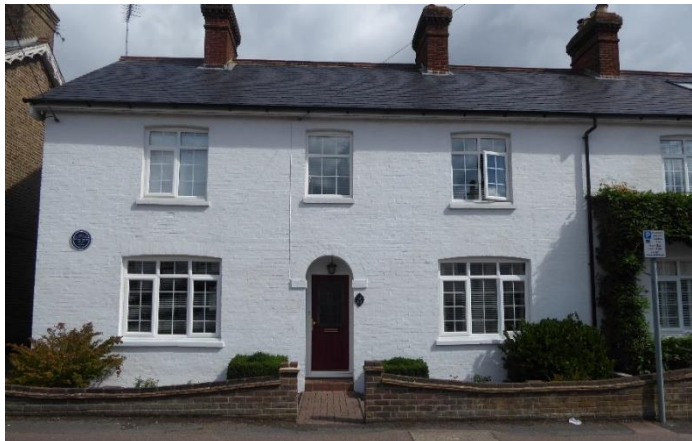
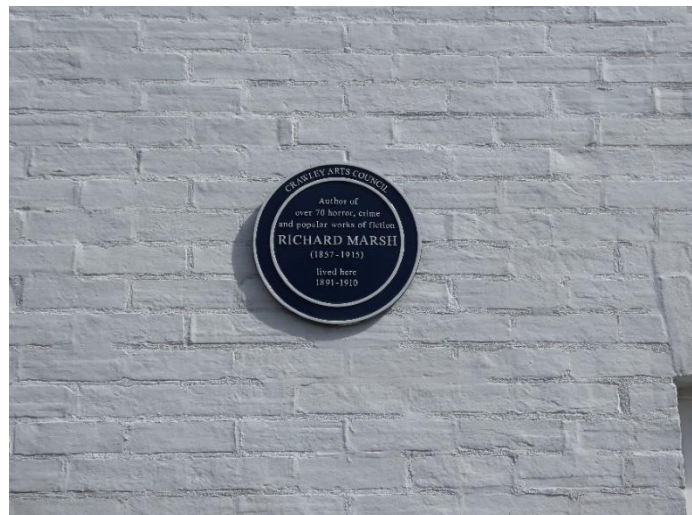
Semi-detached two-storey dwellings. The building is constructed from brick painted white. Each property is three bays wide with the central arched entrance, and the gable ends to the flank elevations have decorative barge boards.

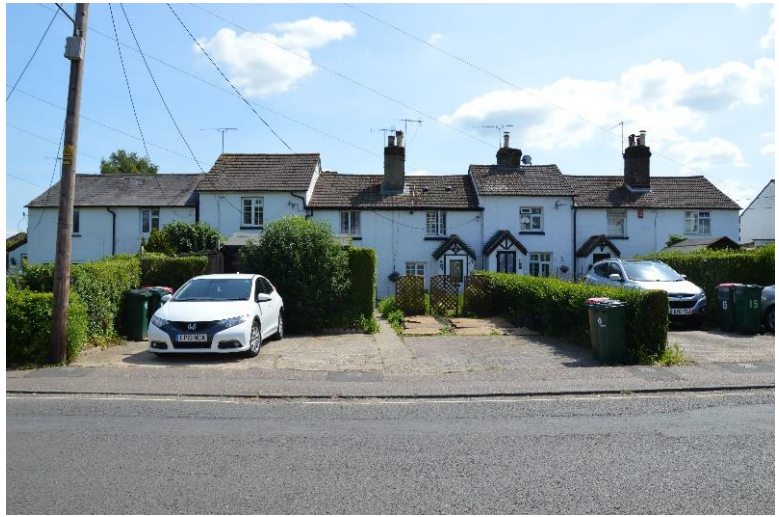
7. Description			
<p>This is a terrace of mid-nineteenth century brick artisan's cottages associated either with the Worth Estate or the railway junction at Three Bridges. The buildings are of varying roof heights, which adds visual interest. However, they are much altered, with the majority of the windows replaced with a variety of differing uPVC since the local list description was first written and most roofs reroofed with concrete tiles, although the original slates on Nos. 7-9 survive. Some chimney stacks have been lost, to 7, 21, 23, and 25. Two sets of telecoms wires spreading out to connect to each cottage results in an unfortunate appearance to the front of the properties.</p>

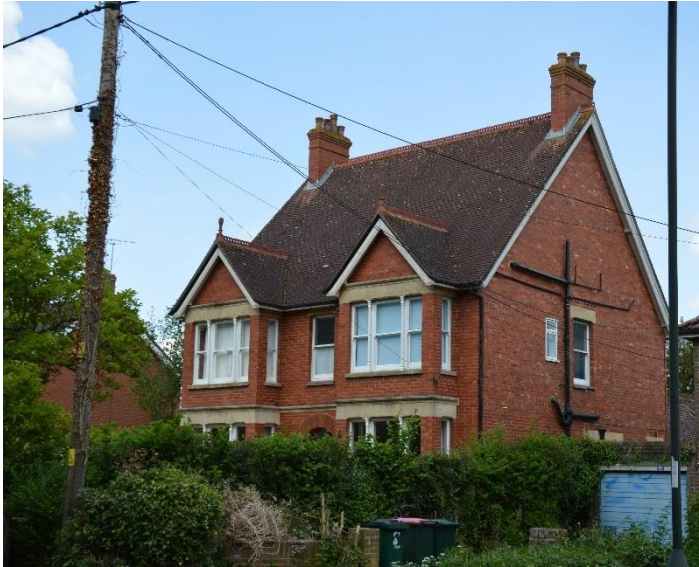
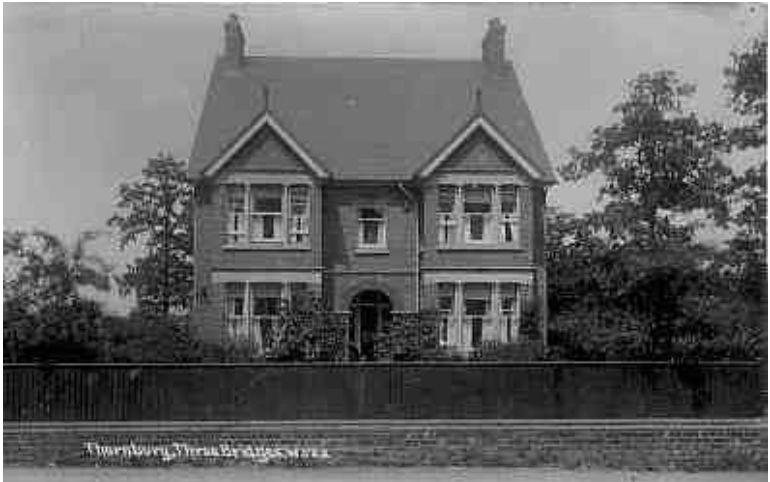
<p><i>Figure 1 Source: http://crawley.cyng.org.uk/CCT-ThreeBridgesRoad.html</i></p>				
7. Description				
<p>Large, detached late-nineteenth/ early twentieth century property. The property has a gable-ended roof form with two prominent projecting gable bays set over two floors. The property is constructed from red brick with a stone string course incorporated into the lintels. The gable pitched bays have clay ridge tiles with terracotta finials. The mullions have attractive cast iron mullions supporting the lintels.</p>

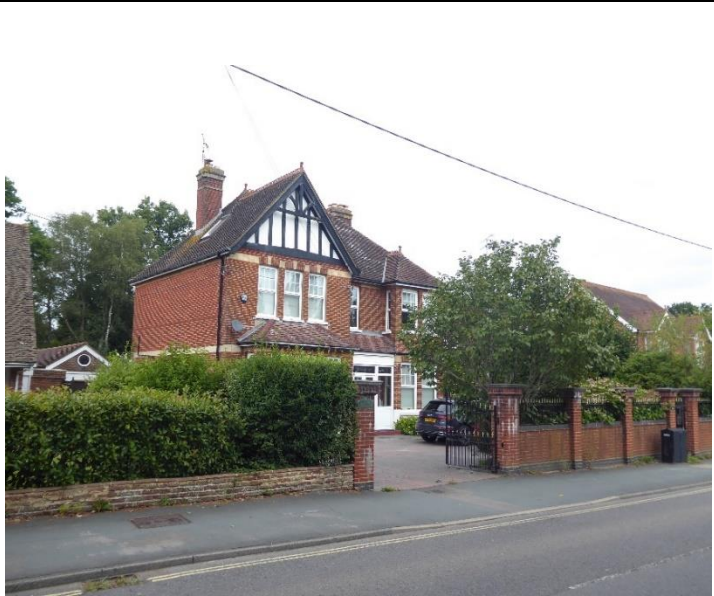
1. Name	141 Three Bridges Rd		
2. UID	TB 08		
3. Address	141 Three Bridges Rd Crawley		
4. Postcode	RH10 1JT		
5. Grid Ref	E: 528205 N: 136806		
6a. Conservation Area	Yes	No	X
6b. If yes, which CA

7. Description			
<p>Large detached, late nineteenth century property. The property has a hipped roof with a prominent gable front and a bay window to the ground floor set under a hipped roof. Under the gable is a decorative half-timbered element with rough cast infill and timber decorative bracing truss to the gable pitch. The eastern side of the front elevation is set back from the principal building line with a bay window over two floors set under a hipped roof.</p>

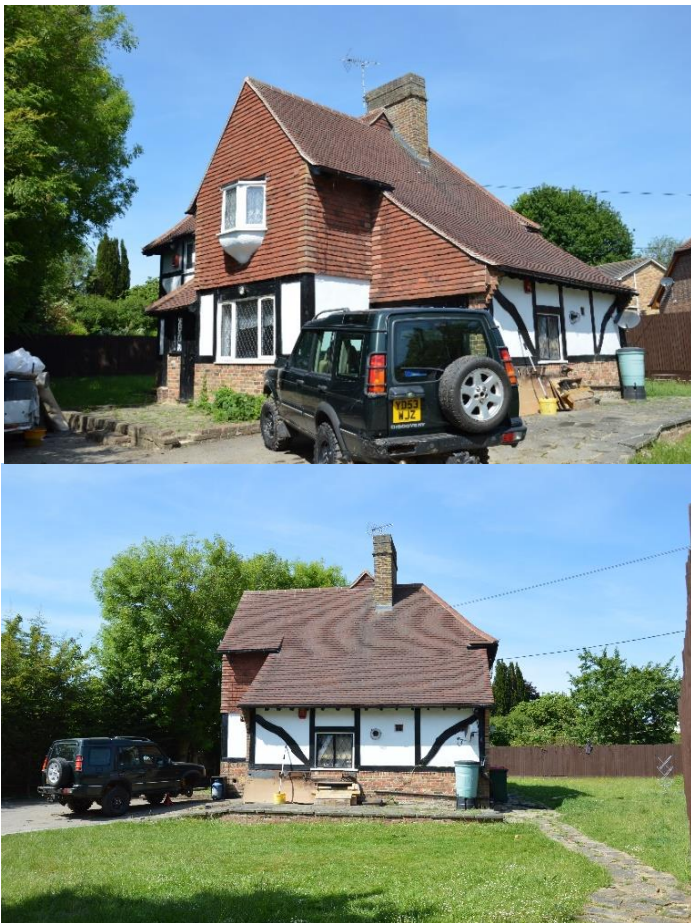
1. Name	142 Three Bridges Road		
2. UID	TB 09		
3. Address	142 Three Bridges Road, Three Bridges RH10 1JP		
4. Postcode			
5. Grid Ref	E: 527857 N: 136606		
6a. Conservation Area	Yes	No	X
6b. If yes, which CA

The building is a house of Tudor revival style house set back from the with a one metre high brick plinth in in stretcher bond with white render and black painted planking above. Above this the walls are covered in red brown plain tiles at first floor and also to roof. The corners to the building feature brick corbelling extending up to the eaves to the west and east. A catslide roof extends over the garage to east. Two large brick stacks rise above the roof ridge which have lost their pots. Some diamond pattern leaded windows are present, other windows have uPVC with Diamond pattern inserts. A canted oriel window is located on the south range gable at first floor.

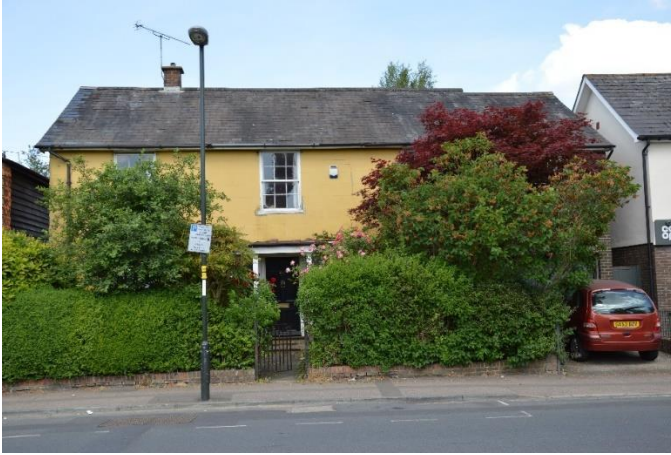
7. Description				
<p>No. 207 is a two-storey detached dwelling, three lights wide with a central entrance. The property appears to retain the original six by six sash windows presenting a strong traditional character.</p>
