Appendix A1 Non-designated Heritage Asset Review Local Heritage List

Crawley Borough Council

December 2020

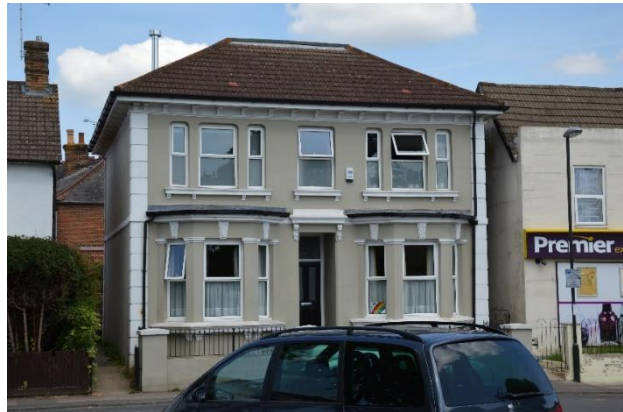
1. Name	225 Three Bridges

2. UID	TB 13			
3. Address	225 Three Bridges Rd, Three Bridges, Crawley			
4. Postcode	RH10 1LG			
5. Grid Ref	E: 528496 N: 136947			
6a. Conservation Area	Yes	No	X	
6b. If yes, which CA	Within suggested Hazelwick Road CA extension			
7. Description				
<p>Detached nineteenth century villa, with a central entrance flanked by bay windows to the ground floor. The roof form is hipped, and decorative elements include quoins, stone headers and brackets to eaves and cills.</p>

10. Aesthetic / Architectural Value							
<p>This villa is architecturally unique within the streetscene, with a well-balanced and symmetrical appearance with attractive features such as eaves and cill brackets</p> <p>The windows have been replaced with modern uPVC which somewhat dilute the architectural value of this property. However, its appearance from within the streetscene remains largely unaltered and, therefore, makes a positive contribution to the area.</p>

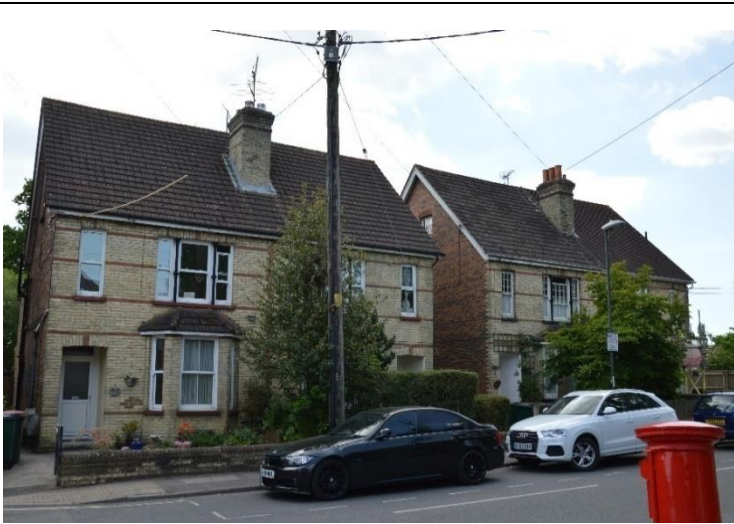
1. Name	150-156 Three Bridges Road		
2. UID	TB 14		
3. Address	150-156 Three Bridges Road, Crawley		
4. Postcode	RH10 1LE		
5. Grid Ref	E: 528334 N: 136826		
6a. Conservation Area	Yes	No	X
6b. If yes, which CA	Within suggested Hazelwick Road CA extension

7. Description			
<p>Pair of semi-detached properties. The front elevation is of gault brick with decorative red brick courses. The side elevations are in red brick. Each pair has a large central gault brick chimney to the front roof pitch. The properties have interesting, cast iron columns to the window mullions which is a prevailing feature along Three Bridges Road.</p>

Numbers 125, 145, 150-6 include cast iron columns to the window mullions which are an architectural interesting and attractive attribute to Three Bridges Road. This feature also demonstrates a clear design relationship between the properties.							
14. Landmark / Townscape Value							
N/A							
15. Archaeological Value							
N/A							
16. Overall Condition							
Good	X	Fair		Poor		Very Poor	
Unknown		Notes:					
17. Recommended for inclusion				Yes	X	No	
18. Date of assessment				18/08/20

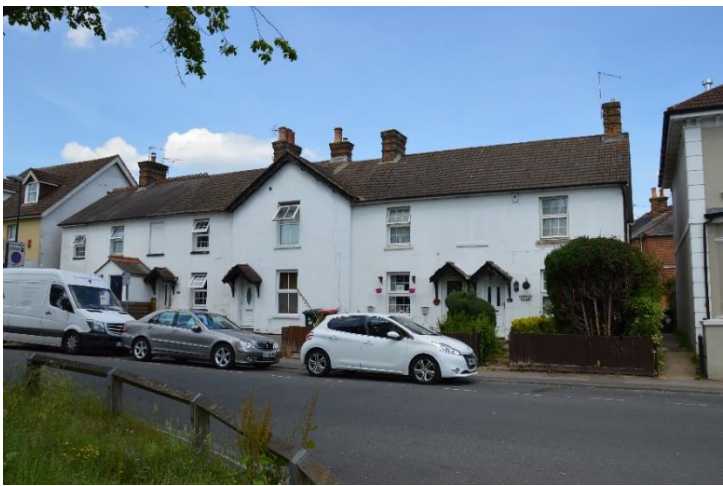
1. Name	215–223 Three Bridges Road		
2. UID	TB 16		
3. Address	215–223 Three Bridges Road		
4. Postcode	RH10 1LG		
5. Grid Ref	E: 528541 N: 136977		
6a. Conservation Area	Yes	No	X
6b. If yes, which CA	Within area of suggested enlarged Hazelwick Road CA

7. Description			
<p>This group of five terraced properties with a central gable date from the late Victorian era, originally of 7 bays. All cantilever porch roofs, fascia boards and timber decoration supports are original apart from number 215 which features an unsympathetic enclosed porch outshot added to its street elevation. Number 215 also features an extension to its west extending the terrace by one further bay. The extension and enclosed porch unsympathetically unbalance the symmetrical street elevation of the building. The majority of the windows have been replaced with uPVC in the original openings, although some original sash windows are retained. The building is largely roofed in concrete tiles, and the render is scored to appear as ashlar masonry.</p>

10. Aesthetic / Architectural Value						
<p>This row has retained some original features, as listed in the description. However, the traditional appearance of this row has been diluted by the loss of original features, side and porch extensions, loss of front gardens replaced by hardstanding, and instalment of unsympathetic UPVC glazing. However, the building retains architectural prominence and aesthetic value and contributes positively to the character of the street and the locality. The building’s large linear form, symmetry and regularity, focused on the central protruding gable gives it particular prominence.</p>

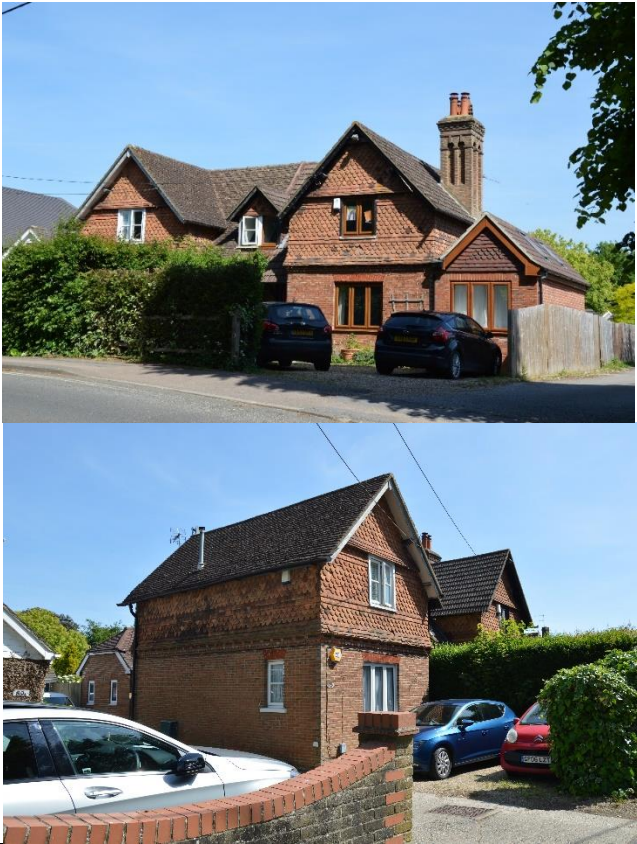
1. Name	89-91 Three Bridges Road			
2. UID	TB 17			
3. Address	89-91 Three Bridges Road			
4. Postcode	RH10 1JR			
5. Grid Ref	E: 527818 N: 136753			
6a. Conservation Area	Yes	<input type="checkbox"/>	No	<input checked="" type="checkbox"/>
6b. If yes, which CA

7. Description				
Semi-detached properties possibly constructed as farm cottages. Constructed of red brick in stretcher bond and with gauged brick lintels. They have fish scale tiles at first floor level and a decorative dentil band of brickwork between the tiles and redbrick ground floor level. The eastern cottage has a prominent decorative chimney and has been extended to at both the rear to the north, and also to the east.

12. Social / Communal Value							
N/A							
13. Group Value							
Yes, although the loss of original roof and different windows goes some way to dilute the aesthetic value of the pair. The cottages are very similar in their form and detailing to the pair of cottages known as Rose Cottages on Balcombe Road. The chimney of the eastern cottage stack is identical to that of the South Lodge to the now demolished Crabbett Park.							
14. Landmark / Townscape Value							
N/A							
15. Archaeological Value							
N/A							
16. Overall Condition							
Good		Fair	X	Poor		Very Poor	
Unknown		Notes:					
17. Recommended for inclusion				Yes	X	No	
18. Date of assessment				27/05/2020

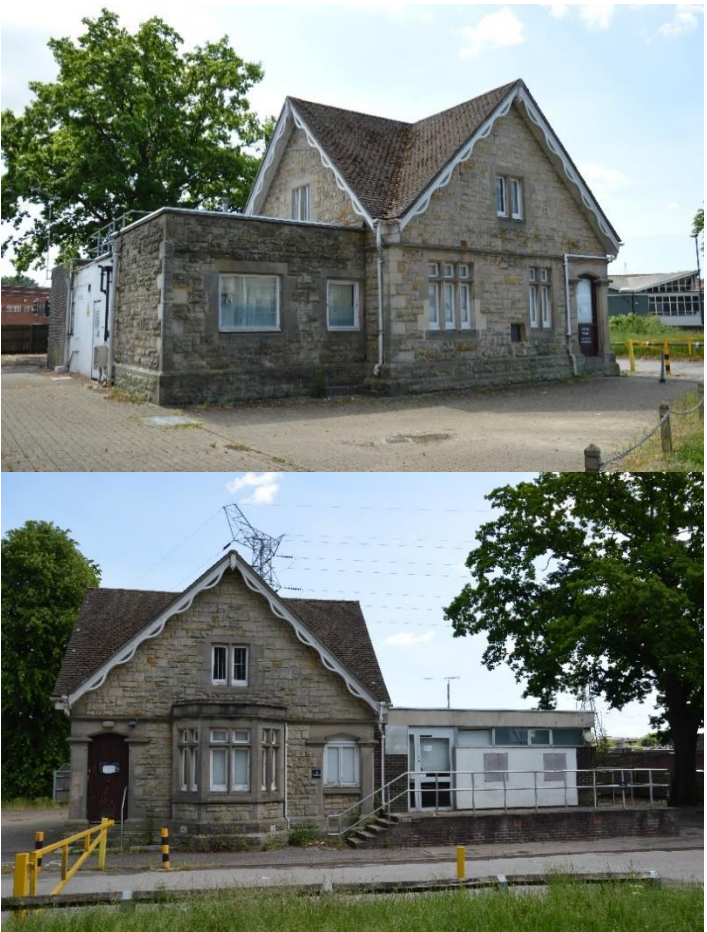
7. Description				
<p>This was formerly the main entrance lodge to the to Tilgate House, and latterly a branch of Barclay's Bank, now closed. The building has a sandstone cruciform shaped roof with gables, a bay window and corner porch. Post-war flat roof side extension, but the exterior is in good condition and the building forms a local landmark. The building shares the same picturesque architectural language as that historic house and associated estate buildings, the materiality is also identifiably similar, being constructed of sandstone in coursed rubble with ashlar detailing to window cills, mullions, lintels, and quoins. No chimney stack remains visible externally, the building roofed in flat plain brown tiles.</p>

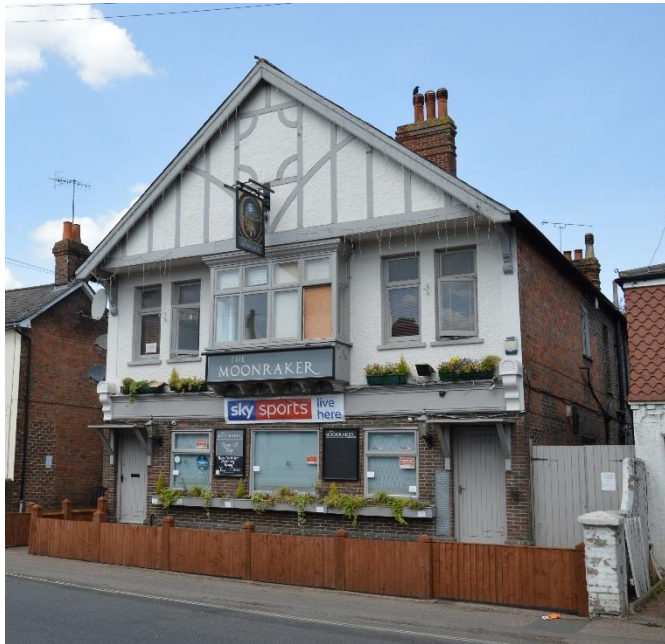
1. Name	The Moonraker Public House			
2. UID	TB 19			
3. Address	199 Three Bridges Road, Crawley			
4. Postcode	RH10 1LG			
5. Grid Ref	E: 528483 N: 136937			
6a. Conservation Area	Yes	No	X	
6b. If yes, which CA	Within suggested Hazelwick Road CA extension.

7. Description				
<p>The Moonraker is a notable building within the streetscene. The property has red brick to the ground floor and flank elevations. The upper two floors of the front elevation are finished in rough cast. The property has a jettied front elevation with decorative half-timbering to the gable end. The building appears to retain original features, such as the chimney and windows. Historically, the building has not always been named the Moonraker. Originally known as the Locomotive, it was rebuilt in an Edwardian Swiss-chalet style in 1905. It opened as the Moonraker in 1977 after a refurbishment.</p>

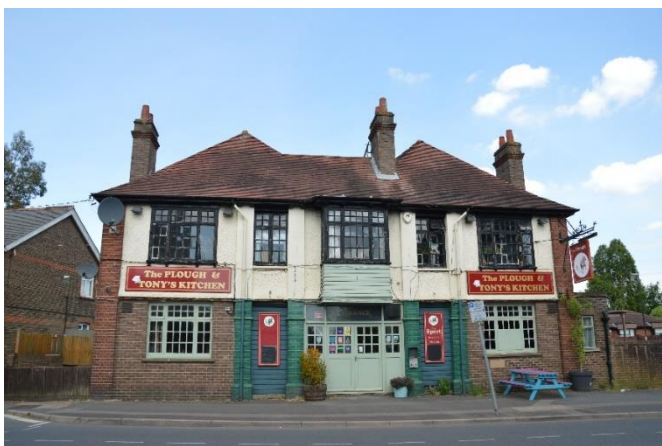
1. Name	The Plough Public House		
2. UID	TB 20		
3. Address	181 Three Bridges Road, Three Bridges, Crawley		
4. Postcode	RH10 1LG		
5. Grid Ref	E: 528427 N: 136895		
6a. Conservation Area	Yes	No	X
6b. If yes, which CA	Within suggested Hazelwick Road CA extension

7. Description			
<p>The Plough Inn is five bays wide set over two storeys, and the roof form is hipped with three substantial chimney stacks. The ground floor is of brick in stretcher bond and render to the first floor. There is a central projecting oriel window to the first floor and the property has timber windows throughout. There are glazed tiled pilasters flanking the principle entrance which may be related to the pub's historical association with the Rock Brighton Brewery.</p>

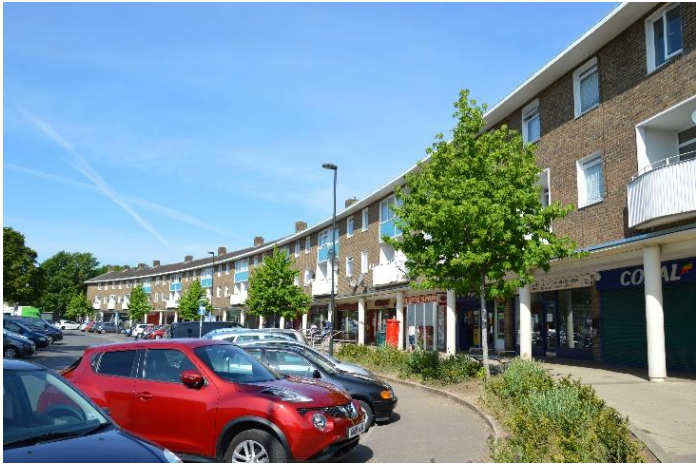
1. Name	Tilgate Shopping Parade		
2. UID	T 01		
3. Address	Tilgate Shopping Parade, Ashdown Drive,		
4. Postcode	RH10 5EQ		
5. Grid Ref	E: 527485 N: 135227		
6a. Conservation Area	Yes	No	X
6b. If yes, which CA

An unspoilt example of a 1950s New Town commercial and residential crescent. All the ground floor shop units are set behind a colonnade supported by simple concrete support columns. The two upper floors are flats with deck access and servicing to the rear. There are recessed balconies at first floor level with irregularly curved balcony supports and handrails in a Festival of Britain style, with blue and white panels set within the balconies and below the second-floor windows above. The shallow roof has a pleasing sweep that is emphasised by the plain fascias. The building is of significant historic and architectural local interest and the best example of a New Town neighbourhood shopping parade in Crawley. The gable ends feature concrete stairs of their period, the western stair being of a particularly impressive slender concrete design. The northern side of the building has been much altered at ground floor. Original windows have been largely replaced with UPVC and the southern elevation features a large number of incongruous satellite dishes fixed at first floor level.

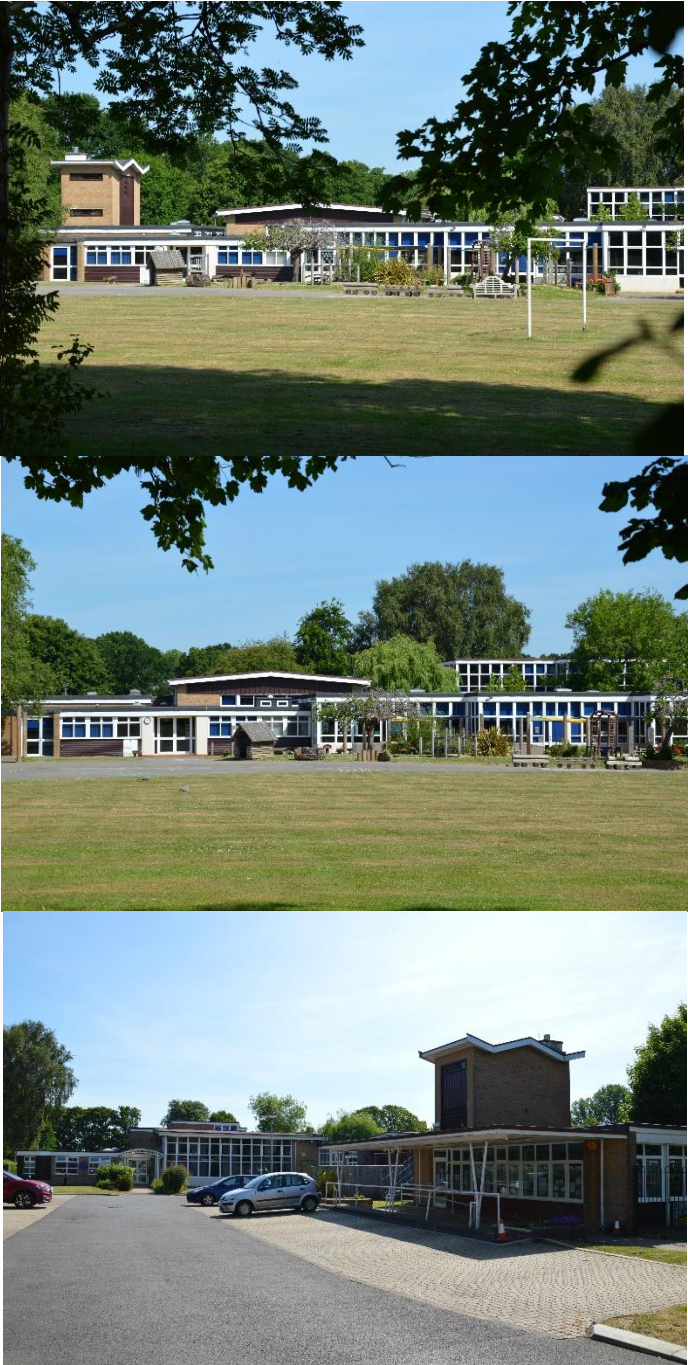
1. Name	The Oaks Primary School			
2. UID	T 02			
3. Address	The Oaks Primary School, Loppets Road,			
4. Postcode	RH10 5DP			
5. Grid Ref	E: 527845 N: 135362			
6a. Conservation Area	Yes	<input type="checkbox"/>	No	<input checked="" type="checkbox"/>
6b. If yes, which CA

7. Description				
<p>A good example of a New Town primary school constructed in the 1950s, of 1-2 storeys, with an eye-catching tower with a W-shaped roof. Buildings are characterised by full height glazing to most walls, and flat or very low-pitched roofs which contribute to an architectural character of horizontality. Windows are largely white uPVC and unlikely to be original.</p>

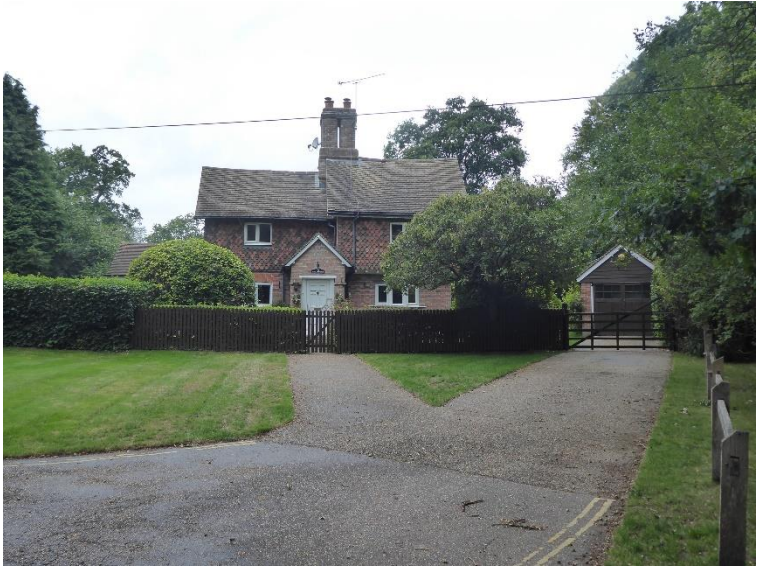
1. Name	Cottage in Tilgate Park between Stables and walled garden			
2. UID	T 03			
3. Address	The Cottage Tilgate Park, Tilgate Drive, Crawley			
4. Postcode	RH10 5PQ			
5. Grid Ref	E: 527355 N: 134190			
6a. Conservation Area	Yes	<input type="checkbox"/>	No	X
6b. If yes, which CA

7. Description				
<p>Located within the land of Tilgate Park along the principal driveway of the former Tilgate House (now demolished). The property is constructed in red brick to the ground floor with hung tiles to the first floor under a gabled roof form. There is a large chimney stack to the centre of the roof. The property was likely to be associated with the former Tilgate House, serving as a cottage of the manor house such as grounds keeper.</p>

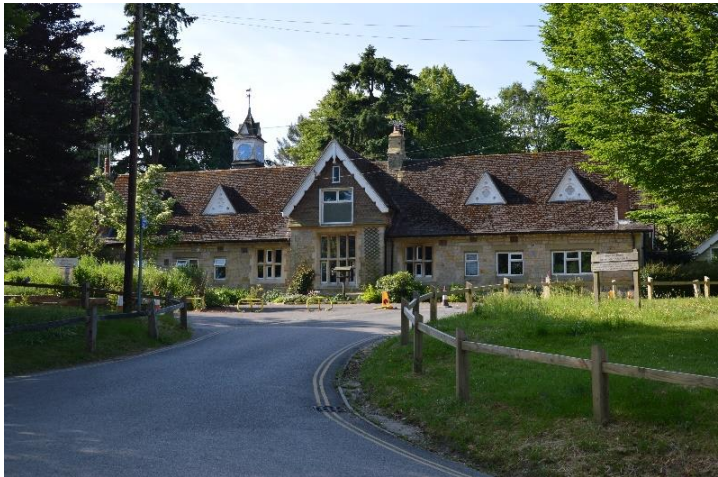
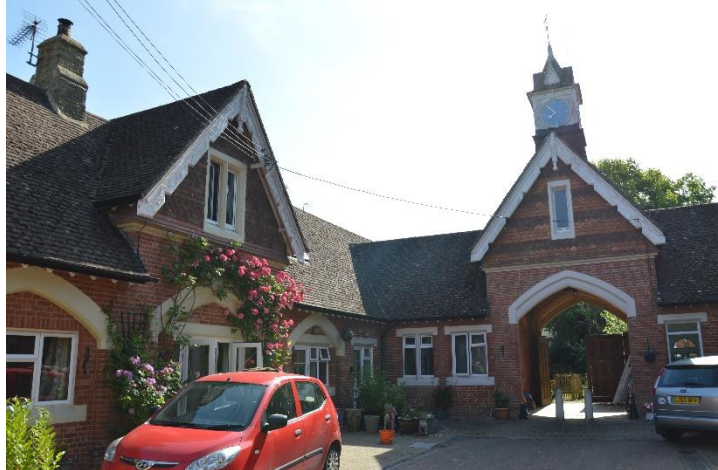
1. Name	Former Stables to Tilgate House			
2. UID	T 04			
3. Address	Tilgate Mansions, Tilgate Park, Tilgate			
4. Postcode	RH10 5PQ			
5. Grid Ref	E: 527562 N: 134454			
6a. Conservation Area	Yes	<input type="checkbox"/>	No	<input checked="" type="checkbox"/>
6b. If yes, which CA

Former stables to Tilgate House, now demolished which stood to the east of the remaining stables. The stables are now sympathetically converted to residential dwellings and retain much of the original features externally and within the courtyard. The former stables are arranged on four sides in a square symmetrical plan with access openings to the east and west, with cross gables to the north, south and east ranges and rising to a single story plus attic. The exterior is of ashlar and coursed rubble sandstone masonry with ashlar quoins to some windows, heavy stone lintels, mullions and sills. The courtyard interior is of red brickwork in English bond with large arched sandstone sills arched lintels. Most of the original openings for stabling and garaging have been bricked in sympathetic brickwork to facilitate use as dwellings. The roof is covered with plain brown tiles. Cross gables feature decorative timber barge boards and plain brown tiles with bandings of brown fishscale tiles. The north range features four decorative triangular dormers to its north slope with quatrefoils at their centres that may be glazed. Historically the roof slope to the internal courtyard featured similar triangular dormers, now lost. Some external windows may be original; however many have been replaced with unsympathetic white UPVC windows.

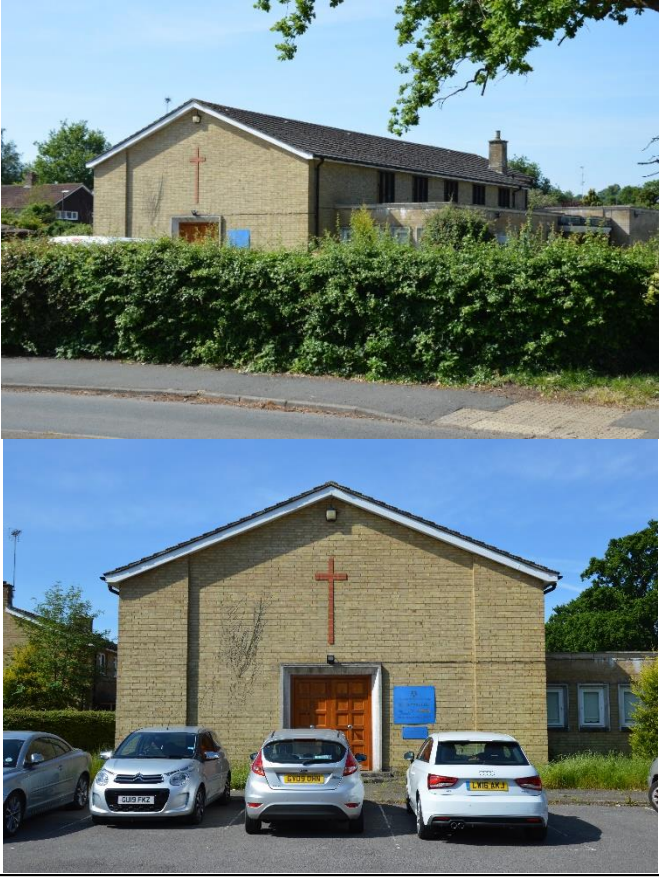
1. Name	St Bernadette's RC Church			
2. UID	T 05			
3. Address	St Bernadette's RC Church, Tilgate			
4. Postcode	RH10 5BT			
5. Grid Ref	E: 527306 N: 135220			
6a. Conservation Area	Yes	<input type="checkbox"/>	No	X
6b. If yes, which CA

7. Description				
<p>Monolithic plain church with single storey ancillary wings to the north and south. The building is of yellow stock brick in Sussex bond/Flemish garden wall bond, featuring chamfered concrete architraves and surrounds to windows and doors. The main east door is timber panelled, windows where original are metal pivot windows, though some have been replaced in UPVC. Black clerestory windows to the church building may not be original. The roof is concrete tiled. The site is poorly kept and becoming overgrown at time of surveying. The building, particularly the architraves and reveals to the doors and windows, and the ordered simple fenestration is in the style of mid twentieth century Scandinavian architecture.</p>

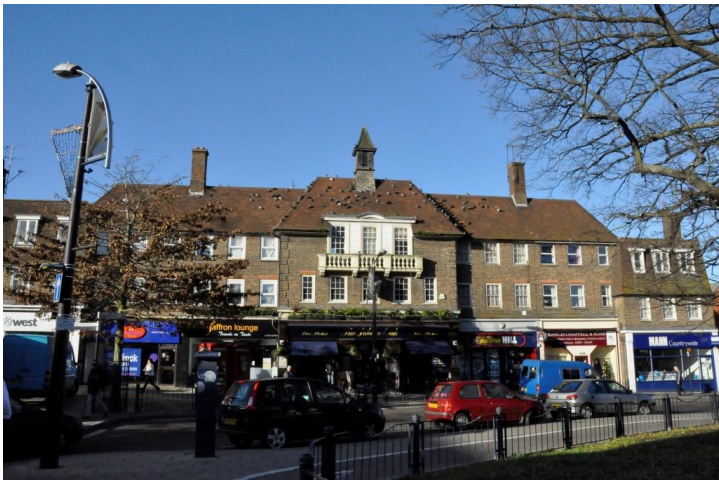
1. Name	The Grand Parade		
2. UID	WG 02		
3. Address	The Grand Parade, High Street,		
4. Postcode	RH10 1BU		
5. Grid Ref	E: 526760 N: 526760		
6a. Conservation Area	Yes	X	No
6b. If yes, which CA	High Street Conservation Area.

7. Description			
<p>A 1930s neo-classical shopping parade. It is three storeys and has seventeen bays, with a projecting central range. This central range has brick quoins, retains its original sash windows and incorporates a classical balcony at third floor level, with weatherboarding above, and the roof is capped with a cedar shingled tower that forms a landmark from the south end of the High Street. The rest of the sash windows in the parade have been replaced with uPVC. Side wings of nine bays (to the south) and three bays (to the north) were added in the 1950s in a complementary style.</p>

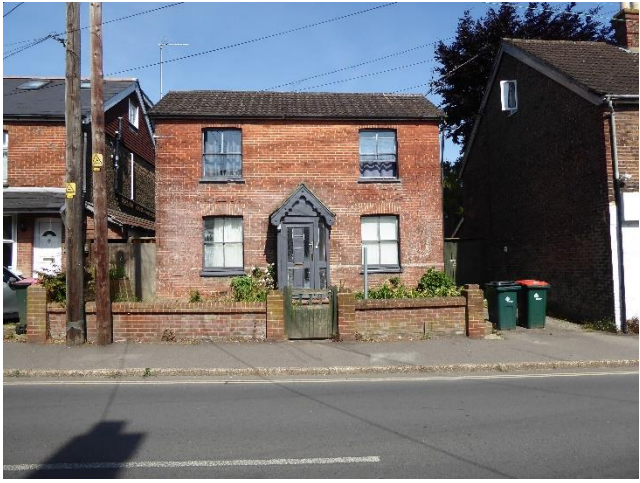
1. Name	No. 11 Horsham Road			
2. UID	WG 03			
3. Address	11 Horsham Road,			
4. Postcode	RH11 7AY			
5. Grid Ref	E: 526339 N: 136547			
6a. Conservation Area	Yes	<input type="checkbox"/>	No	X
6b. If yes, which CA

7. Description				
A relatively well-preserved, restrained example of mid-Victorian domestic architecture. Red brick construction with fine pointing; it is 2 bays and 2 storeys. Retains original 4-pane sash windows and decorative fascia panel on gable end of porch. Modern two-storey extension to the rear.

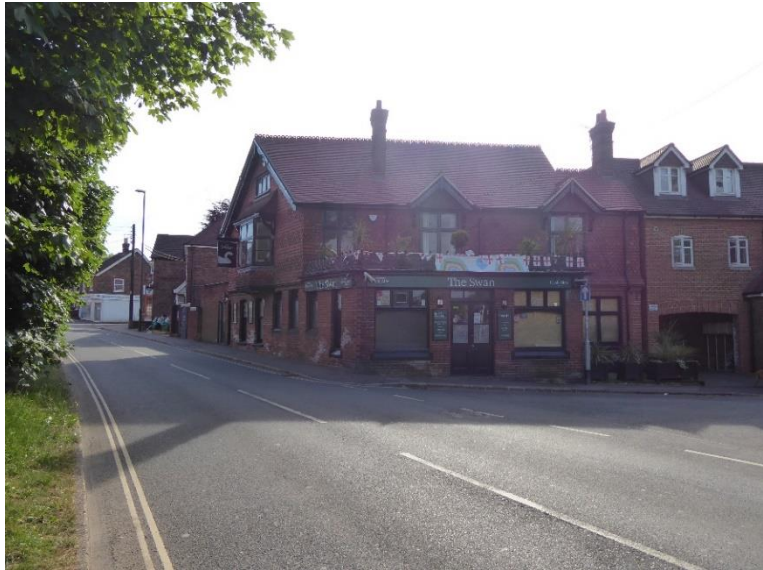
1. Name	The Swan Public House			
2. UID	WG 04			
3. Address	The Swan Public House, Horsham Road,			
4. Postcode	RH11 7AW			
5. Grid Ref	E: 526379 N: 136599			
6a. Conservation Area	Yes	X	No	
6b. If yes, which CA	St Peter's Conservation Area

7. Description				
<p>A good example of a late Victorian public house in the Arts and Crafts style. It is red brick with plain and fishscale hung tiles, clay roof tiles and decorative ridge tiles. There are decorative fascia panels in the gabled dormer windows. There is a flat roofed 'extension' that appears to be part of the original design with a cast iron balcony at first floor level.</p>

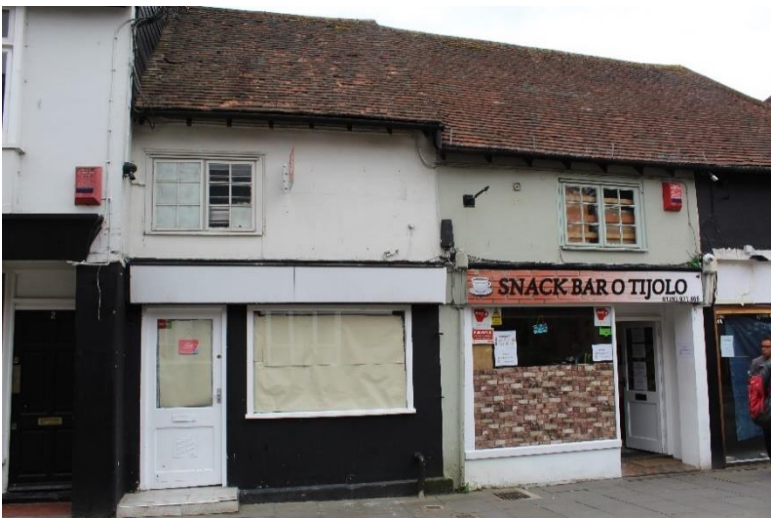
1. Name	Nos. 3-4 Ifield Road

2. UID	WG 05			
3. Address	34 Ifield Road, RH11 7AP			
4. Postcode	RH11 7AP			
5. Grid Ref	E: 526723 N: 136571			
6a. Conservation Area	Yes	X	No	
6b. If yes, which CA	High Street Conservation Area			
7. Description				
<p>A mix of late seventeenth and early eighteenth century two storey dwellings converted during nineteenth century into shops. Some six paned side casement windows survive at first floor level, but most replaced with uPVC (since the local list description was first written) so unlikely to be worthy of statutory listing. Vestiges of the nineteenth century shopfronts remain but doors have been replaced.</p>

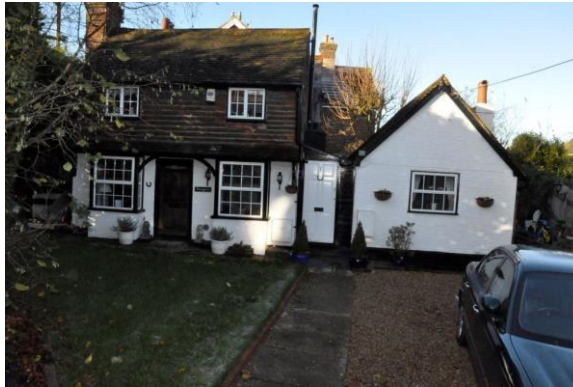
1. Name	Smugglers Cottage		
2. UID	WG 06		
3. Address	1 Victoria Road		
4. Postcode	RH11 7AU		
5. Grid Ref	E: 526493 N: 136576		
6a. Conservation Area	Yes	<input type="checkbox"/>	No <input checked="" type="checkbox"/>
6b. If yes, which CA

7. Description			
<p>According to the original local list description this cottage dates from the 1790s. It is constructed from brick with plain tile hanging at first floor level. There are square bay windows supporting a central porch. The windows appear to have been replaced with uPVC, which suggest it would not be eligible for statutory listing, but it is an historic vernacular building of clear local interest.</p>

10. Aesthetic / Architectural Value							
<p>Although original windows have been replaced by uPVC, it remains largely intact and good example of eighteenth-century vernacular architecture within the area and adds great value to the local historic building stock. It is a unique property within the streetscene which is largely nineteenth century terraces and modern housing.</p>

15. Archaeological Value							
N/A							
16. Overall Condition							
Good	<input checked="" type="checkbox"/>	Fair	<input type="checkbox"/>	Poor	<input type="checkbox"/>	Very Poor	<input type="checkbox"/>
Unknown	<input type="checkbox"/>	Notes:	Unable to fully assess this property from the public domain as it is surrounded by high fencing.
